**Iowa FACE Report:**     **A 17-year-old (minor) farm worker was caught between the raised bucket of a wheel loader and the door header of a cattle shed**

**Case ID:**                 **2011 IA 039**

**Report date:**          **10 December 2013**

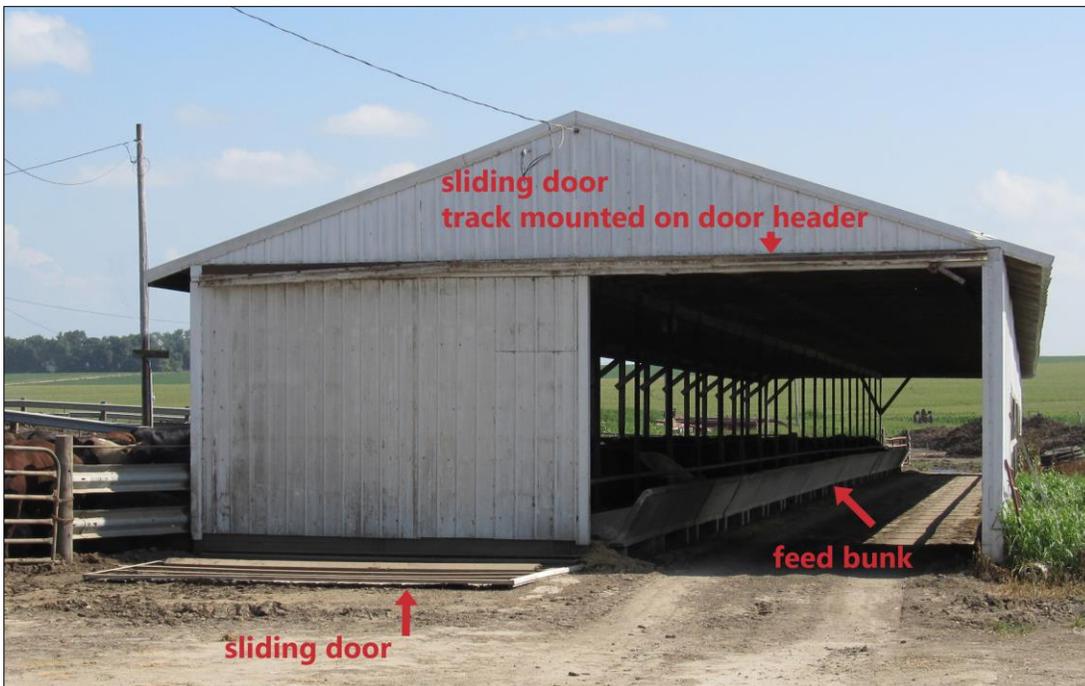
Large sliding doors measuring approximately 18 feet wide by approximately 12-13 feet high provided access to the alley at the north and south ends of the shed. These doors were closed during winter months and open the remainder of the year. The east end of the door track on the north end had come loose from the building and needed to be reattached, and the door, which had been removed some time prior to the incident, needed to be remounted. At the time of the incident, the door was laying exterior-side-down outside the north end of the shed (Exhibit 2).

2. North end of cattle shed

The employer's grandfather came to the site and gathered the victim and another employee to reinstall the sliding door on the north end of the cattle shed. The track for the door had come away from the building at the east end (Exhibit 2) and needed to be repaired and reattached before mounting the door. The grandfather was directing the activity and operating the wheel loader. He drove the wheel loader to the north side of the shed and told the victim to get in the bucket so he could be lifted up to remove a bird nest from the track and work on the roller at the west end (right side) of the track. The other employee (Employee 2) was preparing the overhead door, which was lying on the ground east of the wheel loader.

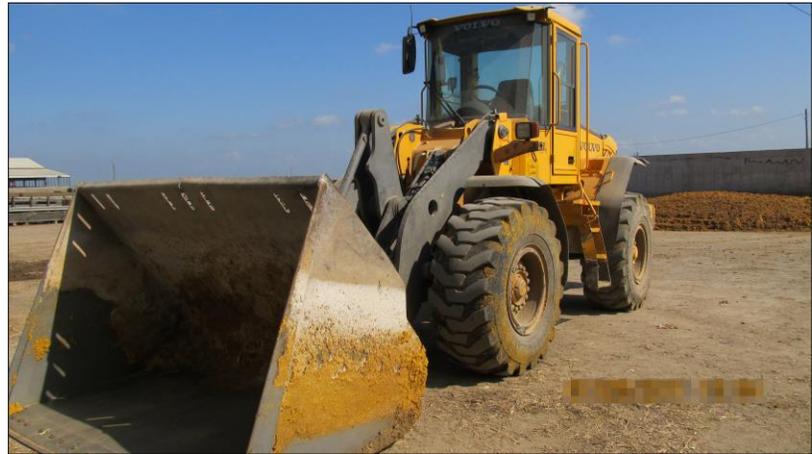
The wheel loader involved in the incident was manufactured in 2003 or 2004 and purchased by the employer in used condition two and one half years before the incident. It was equipped with original equipment, including the large light material bucket attached on the front end (Exhibits 3 & 4). This wheel loader had a scale in the cab and was used mainly to weigh and move feed. The other wheel loader on site was used to transport other materials.

**3. Wheel loader involved in fatality.**

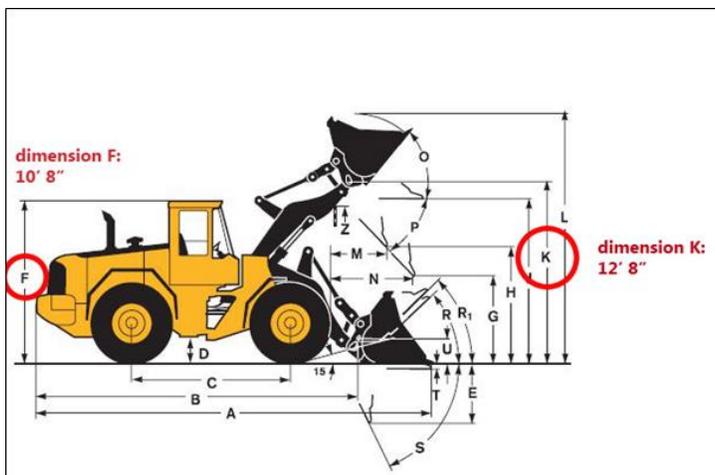
The wheel loaders were used at least a few times a month as personnel lifts. At maximum loader height, the bottom of the loader bucket could be elevated 12 feet 8 inches above ground. The clearance from ground level to top of cab was 10 feet 8 inches (Exhibit 5).

**5. Height dimensions of L70E wheel loader**

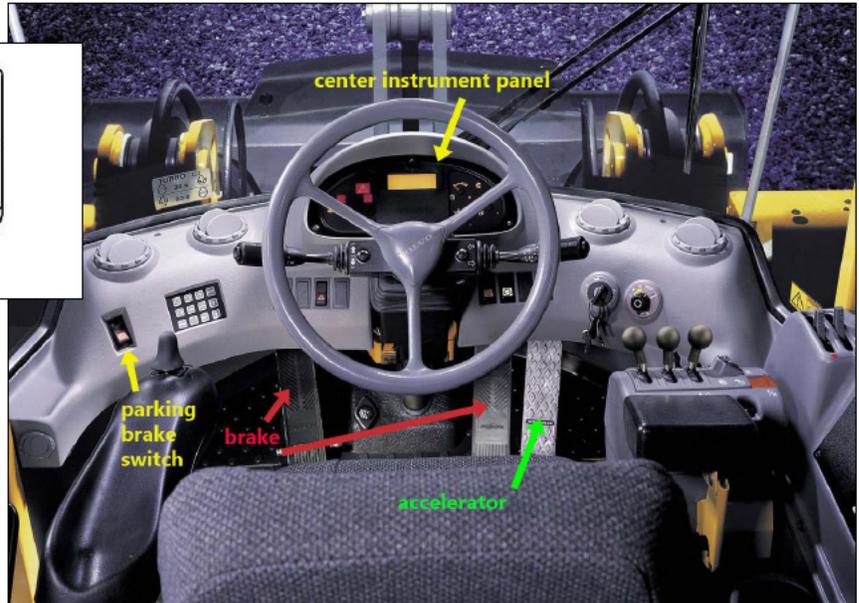
The parking brake for the L70E wheel loader is a dry disc brake positioned on the transmission output shaft. It is electro-hydraulically controlled with this switch on the instrument panel (Exhibit 6). The parking brake is applied by spring force and released by oil pressure with this switch. A catch on the switch acts as a safety feature to prevent the parking brake from being released accidentally.

To engage the parking brake, the gear selector should be moved to neutral, and then the lower end of the switch [labeled ((P))] is pressed. The machine should be completely stationary before depressing the parking brake switch. When the parking brake is applied, the red parking brake control lamp on the center instrument panel is lit (Exhibit 7). The parking brake is released by sliding down the safety catch of the switch and then pressing the upper end of the switch.

**6. Inside of wheel loader cab and diagram of parking brake switch (upper left).**

Training for workers operating this type of equipment should include a) safe operating recommendations included in the equipment operator’s manual, b) the function and indication of warning systems provided by the equipment, and c) how to recognize potentially hazardous work scenarios and improper use applications of the equipment. Operator’s manuals, manufacturer or equipment dealer videos, and training courses can be used to inform both new workers, as well as experienced workers using unfamiliar equipment, regarding safe operating practices. No employees should be allowed to operate equipment without completing training and showing proficiency in safe operation. Additionally, all

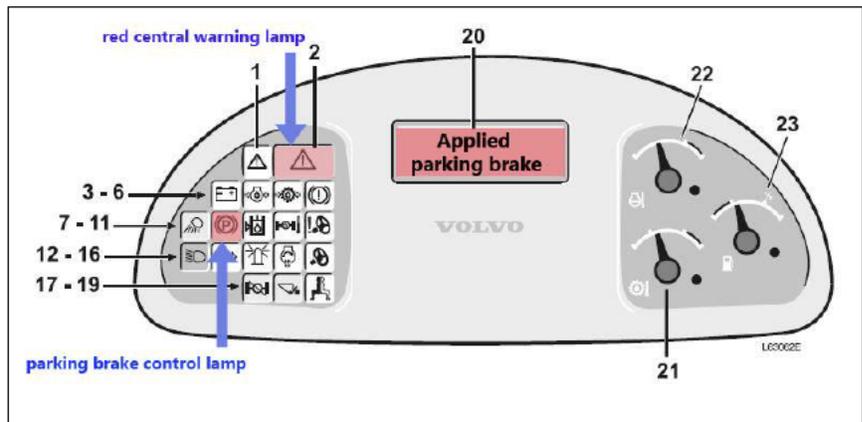
One such scenario involves application of the parking brake while a directional (forward or reverse) gear is engaged. If the parking brake is applied when a directional gear is engaged, the red central warning lamp flashes, the warning buzzer sounds, and a flashing warning text "Applied Parking Brake" is displayed on the center text display unit (Exhibit 7).

**7. Diagram of wheel loader center instrument panel showing parking control lamp, flashing red central warning lamp, and flashing display alarm text in event of parking brake application while directional gear is engaged.**

Although the grandfather drove the wheel loader to the cattle shed, neither he nor Employee 2 recognized the significance of the vehicle warning system’s flashing lights and buzzer notifying that the loader was in gear (instead of neutral, as it should have been) with the parking brake engaged. The wheel loader was relatively new to the farm (less than three years), and the age of the grandfather (87) may have contributed to his perception that he knew how operate the equipment, or he may have relied on his knowledge or experience with prior equipment at the farm.

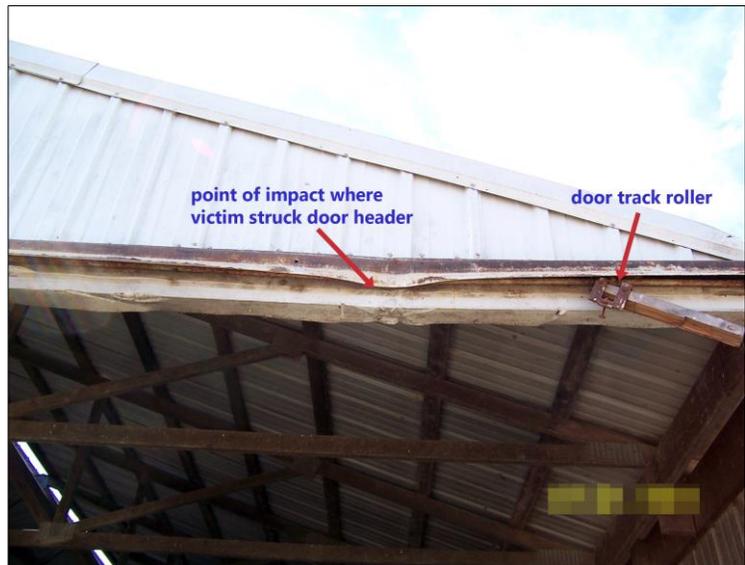
The grandfather attempted to pull forward but he did not know how to release the parking brake. He asked Employee 2 to show him how to release the brake, and Employee 2 then climbed up into the cab and operated the switch to release the parking brake. The wheel loader - which was in forward gear - lurched forward when the parking brake was released. The victim's head was caught between the door header and the back side of the loader bucket as the wheel loader moved forward (Exhibit 8). The back side of the bucket made scraping contact with the door header, and the door header cracked as the wheel loader continued moving forward into the shed (Exhibits 9 & 10).

The sudden movement of the wheel loader caused the grandfather to panic or become confused, and he stepped on the accelerator instead of the brakes, driving the wheel loader into the shed alleyway before he then slammed on the brakes. When the wheel loader stopped abruptly about six feet inside the alleyway, the victim was thrown forward out of the bucket. His head struck the vertical wall of the concrete feed bunk, and he landed 25 to 50 feet ahead of the wheel loader on the concrete floor (Exhibit 11).

**8. Exterior view of door opening showing point of impact where victim struck the door header.**

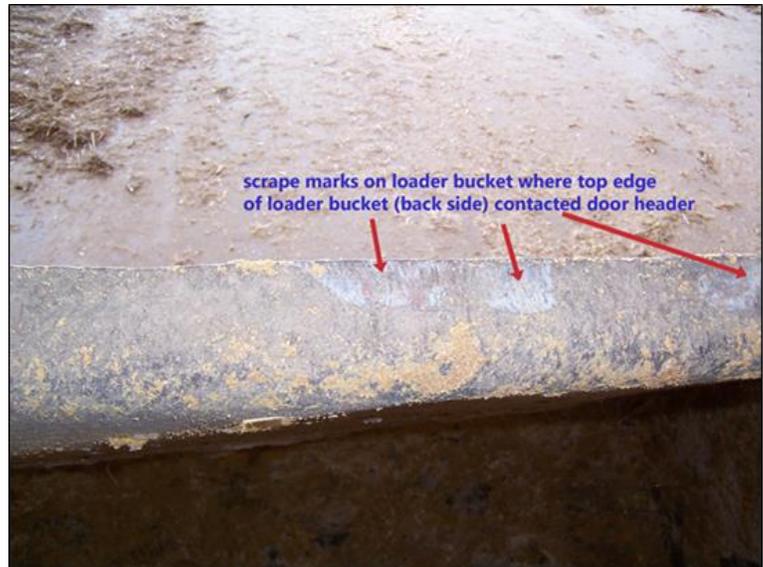
**9. Scrape marks on top edge of loader bucket.**

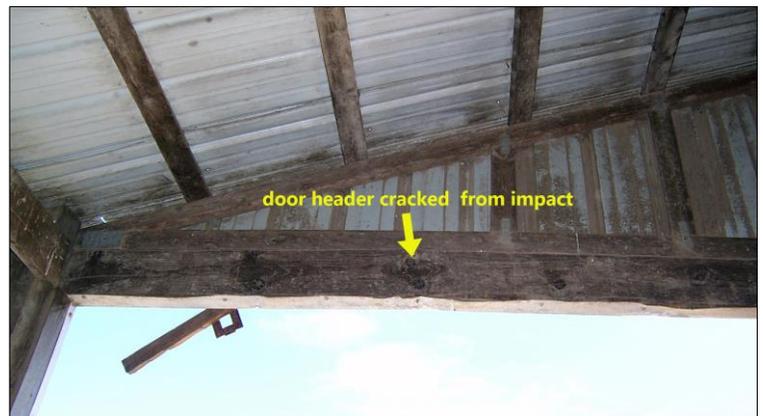
**10. Interior view of shed doorway.**

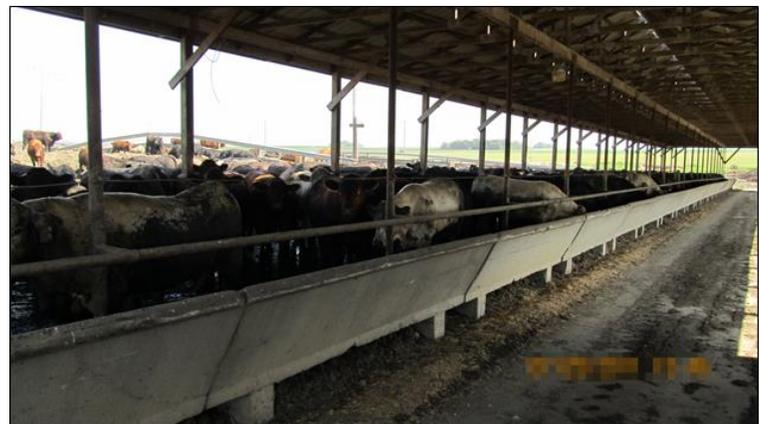
**11. Concrete feed bunk the victim struck upon being thrown from bucket.**

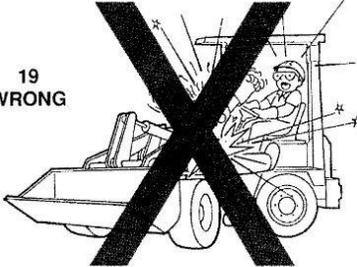
### 12. Excerpts from L70E Operator's Manual (above) & AEM Wheel Loader Safety Manual (below)

The L70E wheel loader operator manual and the Association of Equipment Manufacturers (AEM) wheel loader safety manual specifically state that a wheel loader should never be used for a work platform, lift, or personnel carrier, and that riders are not permitted on the wheel loader. Using a loader bucket as a personnel lift or work platform is unsafe for several reasons:

- the loader bucket has no protective railing or enclosure to prevent a worker or rider from falling out;
- the work area on the bucket is small and narrow, posing risk of crushing if the loader is moved in a tight or narrow area near stationary objects, as was the case in this fatality;
- there is no means for a worker in the bucket to control the position or movement of the bucket or the loader;<sup>1</sup> and
- an operator's ability to see and perceive the position of the bucket, a worker in it, and a nearby stationary object may be limited, depending on the position of the bucket at its raised elevation.

**! WARNING!**  
The bucket must not be used for transporting or lifting people – as this might lead to accidents.

Never use a bucket for a work platform or personnel carrier.

### 1. Employers should select and use appropriate equipment designed for working at heights, such as personnel lifts, ladders, or scaffolds.
