**FROM:** Iowa FACE      Case No. 2012 IA 009      Report Date: 11 September 2012

**SUBJECT:** Bathtub refinishing technician died from inhalation of paint stripper vapors

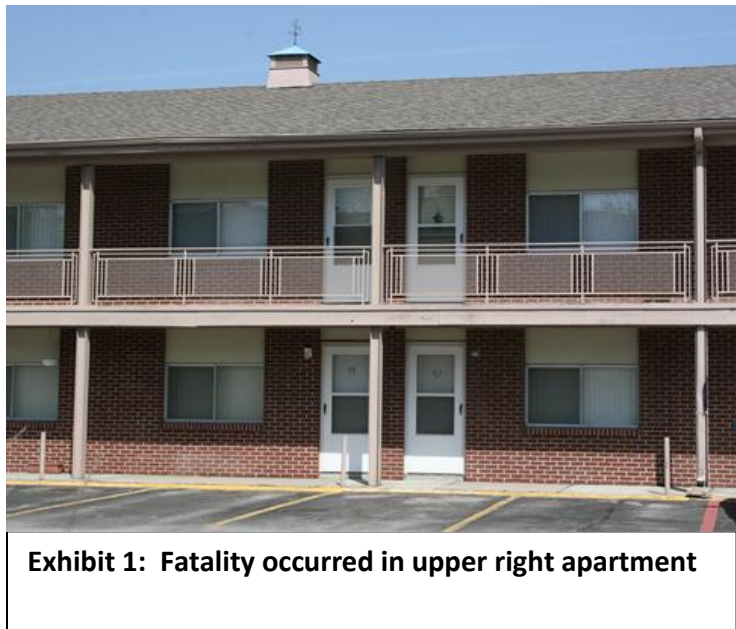
The fatality occurred during early 2012, in a second-story apartment of a multi-apartment complex (Exhibit 1). The apartment was accessed by a single exterior door, via an exterior stairway at the end of the building. The manager of the apartment complex noted that it was common practice to contract for bathtub refinishing services when needed, in preparation for leasing to new renters. The day of the fatality was the third or fourth time this resurfacing business had worked at this apartment complex. The apartment manager recalled that the decedent had worked at the apartment complex on at least one of those occasions prior to the fatality.

**Exhibit 1: Fatality occurred in upper right apartment**

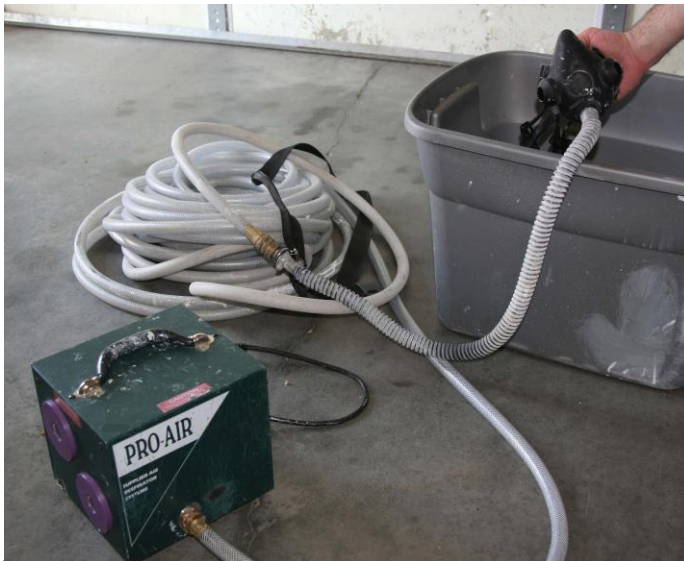
**Exhibit 2: ProAir 40 Fresh Air Respirator was to be used while stripping bathtub surface**

There are several shortcomings of the half-face Pro-Air 40 respirator device available to the surface refinishing employees. The Pro-Air 40 is not included in the NIOSH Certified Equipment List and does not meet minimum respiratory protection requirements for methylene chloride exposure. (The Pro-Air 40F – “F” designating for use with full face mask – is currently certified with approval number 19C -0320.) Pro-Air 40 systems are marketed online at several vendors and described as “NIOSH-approved” respirators, which misleads prospective users of the capabilities and protection provided by the respirator.

The configuration and protection factor of the Pro-Air 40 Fresh Air System does not meet criteria for methylene chloride exposure that may reach IDLH concentrations. Additionally, half-face mask configurations do not protect the eyes from irritation caused by methylene chloride vapors. The proper respirator for exposures up to 5000 ppm is an atmosphere-supplying respirator with full face mask, operated in pressure demand or positive pressure mode.

The Pro-Air 40 system used by the company instructs users to place the turbine in fresh ambient air of Grade D quality<sup>4</sup> or better. The Pro-Air 40 turbine unit includes two high efficiency particulate air (HEPA) filters that are replaceable but users do not have good indication to gauge a pressure drop if airflow is restricted or decreased due to turbine malfunction or filter loading. Using this system

within a room or apartment or even interior area of a home or business would provide no protection from methylene chloride vapors that would bypass HEPA filters and re-entrain into the supply system. Using this system in the winter, placing the turbine outdoors in a “fresh air” environment may have resulted in uncomfortably cold air being delivered to the wearer; it is not known if this deterred the technician from using the respirator equipment in her van. Although two 40-foot lengths of 5/8” tubing were found in the van that could have allowed an outdoor placement of the turbine, the NIOSH certification (for the Pro-Air 40F) specifies only an approved length of 40 feet. The technician and employer were uninformed of the limitations of this type of respirator, although it was recommended by the parent company selling regional distributorships. The employer was unaware that only full-face atmosphere-supplying respirators are approved for methylene chloride.

A formal respirator program would have assigned responsibility for proper selection, maintenance, use, and employee training, and assured that proper fitting full-face respirators were available for employees. The appropriate respiratory protection for methylene chloride exposures that could reach IDLH concentrations is a full-face, supplied-air respirator.

If methylene chloride-based paint removers continue to be used, they should be used only with positive pressure supplied air systems such as self-contained breathing apparatus (SCBA) or airline respirators with SCBA backup, especially when exposure concentrations are not known or if it is not possible to effectively ventilate the work area. Workers and bystanders should not rely on odor as a warning property for dangerous exposures, as the odor threshold (250 ppm) is 10 times the OSHA Permissible Exposure Limit (PEL, 25 ppm) and near the 15-minute short term exposure limit (STEL, 125 ppm). Direct-reading equipment would be needed to determine hazardous concentrations of methylene chloride on site. Examples of direct-reading equipment include detector tubes, which allow “grab samples” or air to be collected that show the presence and concentration of vapors tubes that change color, or portable direct reading instruments

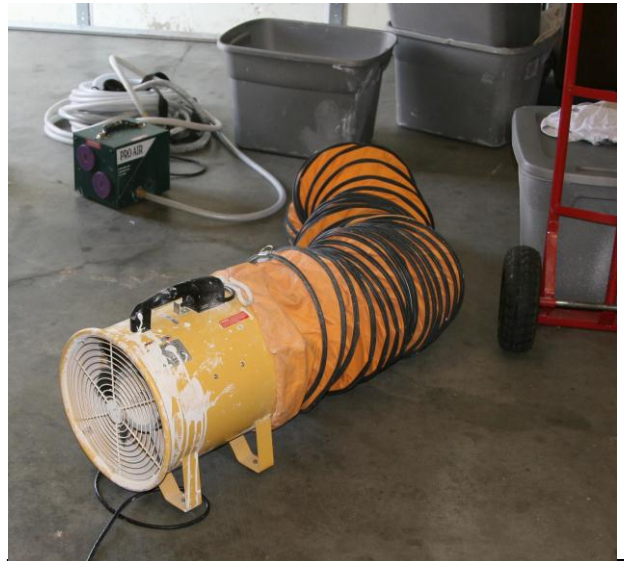
**Exhibit 3: FlowPro utility blower (in foreground) was to be used to exhaust chemical vapors from the work area**

Employees were also directed to use a portable Q Standard Utility Blower (12-inch diameter fan, 2905 cubic feet per minute, 4/7 horsepower, Model 39012) with Q Standard Ventilating Hose (12-inch diameter, 20-foot, Model 177771) flexible duct to remove contaminated air from the work area and exhaust it outside to a location remote from the respirator air supply source (Exhibit 3).

A 2905-cfm utility ventilation blower with two 20-foot sections of flexible ductwork was found in the work van that the technician drove to the site. This equipment was in the van with a portable hand cart to transport her storage totes of supplies and equipment. It is not known why, on this occasion, the decedent did not use ventilation controls and respiratory equipment, since apartment personnel had on prior occasion seen her use this equipment. Since the utility blower was not known to have malfunctioned or had operating problems, possible explanations may be that:

The actual reasons for not using the exhaust ventilation and respirator were not known. Nor was it known if the technician on other occasions had omitted these safety measures with no ill consequences. This large utility blower and duct system, placed on the bathroom floor in the room

with the technician, would be an improvement to no ventilation, but provisions must be made for clean supply or “makeup air” for the exhaust system to work properly. A better option is to locate a local exhaust hood closer to the stripper product, since the tub wall and even the technicians themselves could potentially block the direct pathway of contaminated air at the source to the fan.

Using appropriate makeup air and local exhaust ventilation in a push-pull system would have diluted methylene chloride vapors in the room. Because methylene chloride has a high vapor pressure and is heavier than air<sup>3</sup>, the better alternative is to position an exhaust hose to the side and as low to the interior of the tub as possible to draw vapors down and away from the worker who may be leaning over the tub to work. Capturing and removing vapors closer to the source is a more effective exhaust.

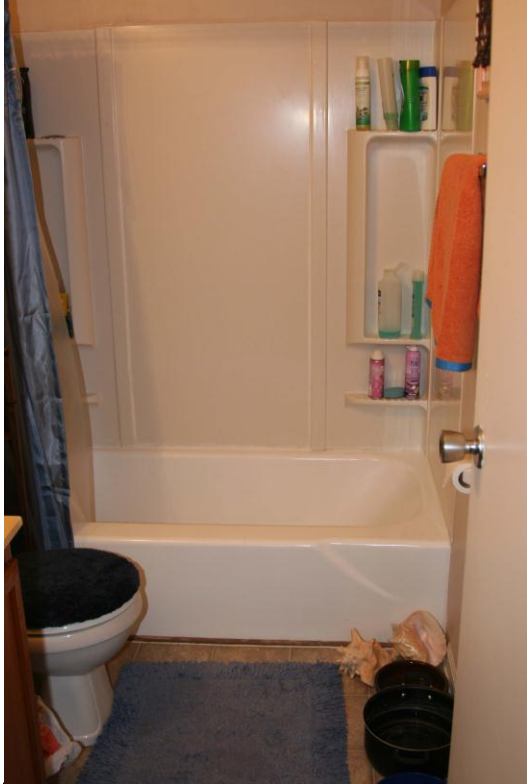
**Exhibit 4: Configuration of bathroom**

The decedent had been working in a small bathroom that was approximately 5' wide x 7.5' deep x 8' high (Exhibit 4). The standard size bathtub (29" wide x 60" long) was on the far end of the room and extended the width of the bathroom. The room had a ceiling exhaust fan which was not turned on. Most of the original tub finish had been removed, and the decedent's scraper and knee pad (presumably used as a cushion) were found in the tub (Exhibit 5).

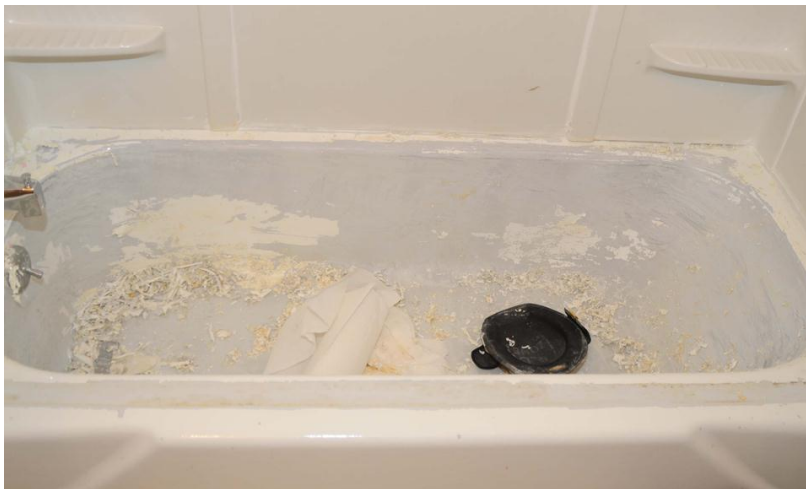
Responders described a strong chemical odor in the apartment. An open one-gallon can of Klean Strip Aircraft® Low Odor Paint Remover was found in the room, with about 105 ounces of product remaining in the 128-ounce can (Exhibit 6). The door and windows of the apartment were closed, and there was no supplemental ventilation supply or exhaust in use.

**Exhibit 5: Bathtub where technician was found**

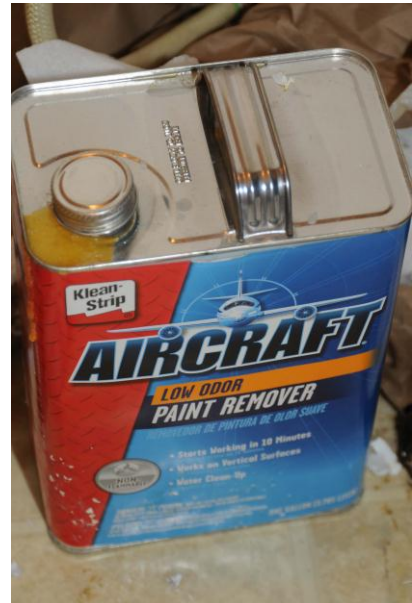
**Exhibit 6: Recapped can of methylene chloride paint remover found in room**

Labeling information on the one-gallon can of states: *THIS PRODUCT IS DESIGNED FOR APPLICATION BY TRAINED PROFESSIONALS USING PROPER EQUIPMENT UNDER CONTROLLED CONDITIONS. THIS PRODUCT IS NOT INTENDED FOR SALE TO THE GENERAL PUBLIC.* The business owner at this site purchased the product locally from a retail supplier specializing in coatings, hardware, solvents, and spray equipment; the product is currently available to the general public through coatings suppliers and automotive supply companies in brick and mortar stores, and through online sales (e.g., amazon.com)<sup>1</sup>. While chemicals may be generally available to the public for purchase and use, employers must understand and communicate the hazards of workplace chemicals to all affected employees, whenever chemical uses are greater in duration or frequency than those of a common consumer<sup>2</sup>. The product label indicates that this material is *not* intended for use by the common consumer, necessitating chemical-specific training.

In this case, the employer returned to finish the tub stripping and resurfacing a few days after the fatality; he avoided using the usual methylene chloride stripper and instead completed the stripping process manually, using scrapers and sanding. This manual process is likely to take longer, but would avoid chemical exposures. Other alternative products that are low-toxicity - such as benzyl alcohol or soy-based stripping products - should be considered, to determine if these low-hazard products can achieve the efficacy of methylene chloride products even if the method may take longer to work.

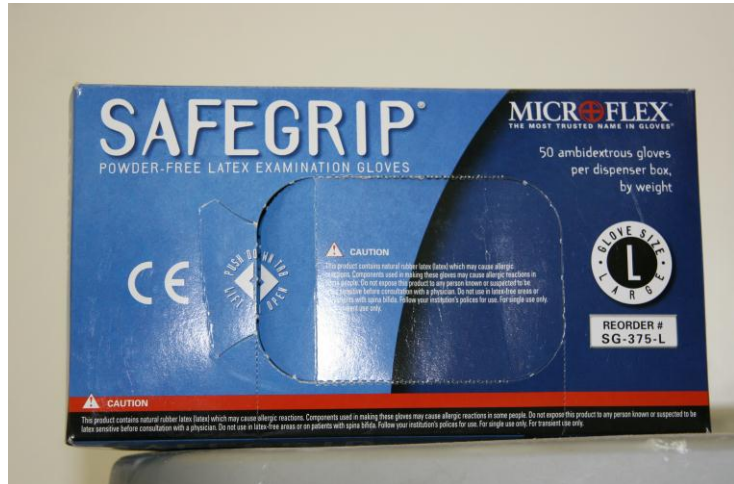
The decedent was wearing a short sleeved tee-shirt, painter pants, and two layers of latex gloves (Exhibit 7). She wore no respiratory protection or eye protection. The decedent's cup of fountain pop was on the counter of the vanity in the room. The employee's Pro-Air 40 Fresh Air Respirator with two 40-foot sections of supply tubing and FlowPro utility blower with two 20-foot sections of flexible duct were found in the cargo area of the company van the decedent had driven to the site.

**Exhibit 7: Gloves used by technician**

Adherence with the standard would have also provided guidance for clothing and gloves to protect exposed skin. The technician's work clothing did not provide coverage to her forearms; the latex gloves she wore were not chemically resistant to methylene chloride. Long gloves made of butyl rubber, polyethylene/ethylene vinyl alcohol (PE/EVAL, 4H™ and Silver Shield™ brand), or Teflon™ would protect the hands and forearms from contact with methylene chloride and methanol.
