FROM: Iowa FACE Program Case No. 3IA20 Report Date: October 10, 2003

SUBJECT: Teenager Dies in Tractor Overturn When Home-Made Rollbar Fails

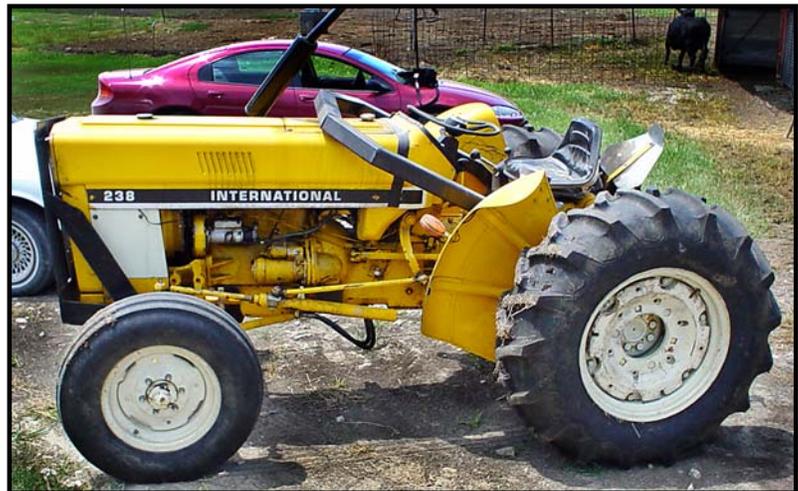
Photo 1 – Side view of tractor showing rollbar collapsed forward.

up the tractor into position, adjacent to the 6-inch (15 cm) diameter wooden fence post. The tractor was facing up a slight slope. An old chain with 1/4 inch (6 mm) links was secured to the bottom of the post and the other end was looped around the rear tire. Normally, as the wheel would turn, it would pull the post upward and forward. The boy had the tractor in first gear, with throttle applied. As he released the clutch, the post, buried 4 feet (1.2 m) deep in dry ground, did not move, but the tractor's front end jumped upward. The grandfather yelled, but the boy had no time to react, and the tractor rolled completely over backwards. The self-made rollbar was sturdy and did not break or bend, but large pieces of the axle housing snapped off from both sides as the rollbar collapsed. The boy was instantly crushed underneath. The tractor had been previously used for city maintenance, and originally had a two-post factory-installed Roll-Over Protective Structure (ROPS). The tractor was sold through an auction and was bought by the family without this ROPS. The original mounting brackets were still in place, but the long bolts connecting the top and bottom brackets were missing. The new rollbar was welded to the existing top bracket, which was bolted only to the top-mounting base of the cast iron axle housing. Without the long bolts between the top and bottom brackets, this installation did not provide adequate strength for the rollbar attachment to the axle, and the axle housings broke, making the rollbar ineffective.

Recommendation 3: *Self-made rollbars are not recommended as they may not provide adequate structural strength in an overturn.*

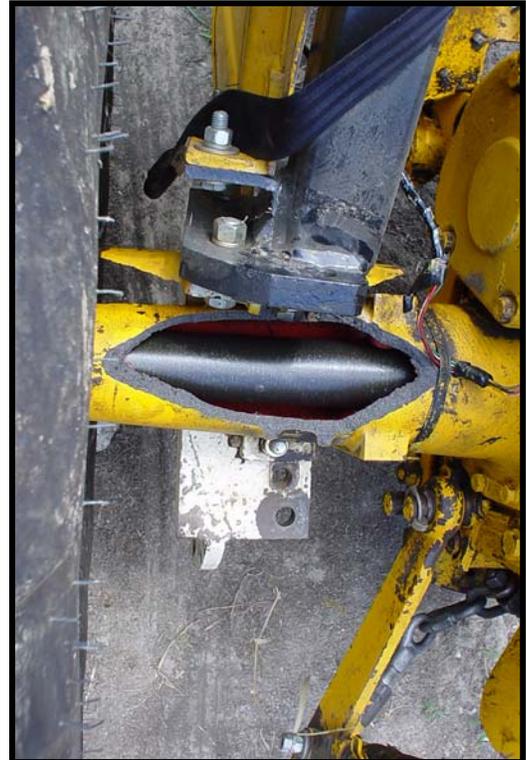
The tractor was bought used from an out-of-state dealer who had in turn purchased it at a public auction. The tractor was previously used by a city maintenance crew for mowing and general maintenance duties. It was a 1979 International Harvester model 238, manufactured in Great Britain, and was originally equipped with a 2-post factory-mounted ROPS. When purchased by the family, the tractor did not have the original ROPS intact. The ROPS frame had been cut off above the attachment points for the fenders, and all long bolts had been removed. The bottom brackets had other bolt holes and mounting elements, some of which showed wear from previous use. (see Photos 2+3).

Photo 2 – Close-up view of left rear axle, looking down from the top.

bracket. The mounting brackets had approximately 2x2 inch (50x50 mm) and 2 inch (50 mm) high stubs of steel remaining from the original ROPS. The new rollbar was made to slip over these stubs from the original ROPS, welded to the mounting brackets, then painted with black paint (see Photos 2+3).

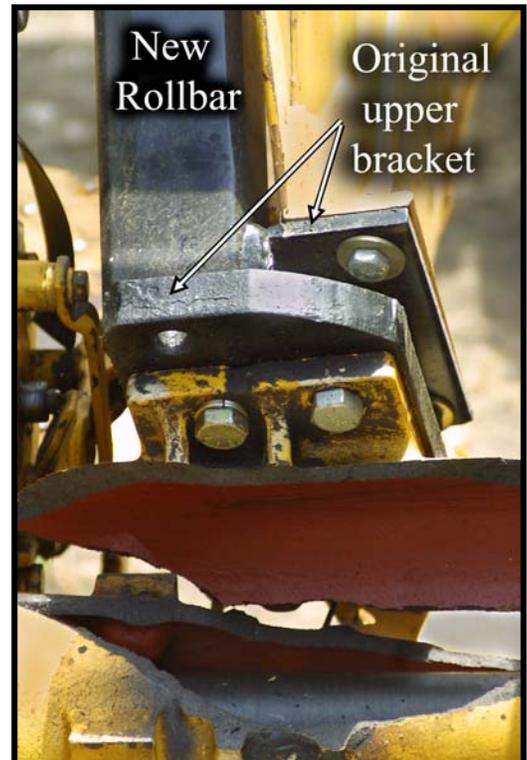
Photo 3 – Close-up view of right axle showing construction of rollbar and its attachment to the axle housing with short bolts. This also shows the original ROPS upper bracket with fender attachment, repainted to look new (refer to Diagram).

By visual observation, the rollbar was built very well with precise cuts, consistent welding, and detailed finish. The seatbelt was bolted onto the sides of the rollbar. The short bolts connecting the brackets to the mounting bases were different grades (SAE Grade 5 and 8). The missing long bolts connecting the top and bottom brackets were not replaced. The bottom mounting brackets had bolt holes and wear marks which could give an impression that the brackets were used for some purpose other than being part of the ROPS mounting system.

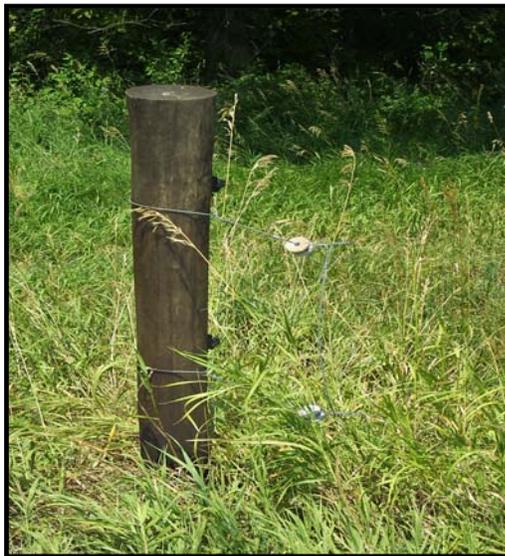
Photo 4 – Wooden fence post, similar to the one in the incident.

The victim and his grandfather were removing an electric fence line surrounding the old pasture (see Photo 5). The fence was made of 6-inch (15 cm) diameter creosote wooden posts (see Photo 4) and small fiberglass posts between the wood posts. The posts appeared relatively new, and were in good condition. They were eight feet (2.4 m) long and set approximately 4 feet (1.2 m) deep in the ground. The fiberglass posts were easily removed by hand, but the wood posts required significant force. Initially, the grandfather attempted to pull this post using the 3-point hitch lift arms of the tractor. This was unsuccessful, for the hydraulics did not have enough power. Their alternate method was to use the rear wheel and a chain, which had worked successfully prior to this incident. They backed the tractor in position with the right rear wheel adjacent to the post. A chain was attached to the base of the post, and the other end looped through the rim and around the rear tire. On other occasions, when the rear wheel turned, it would yank the post up and forward out of the ground, making it a quick and easy method to remove posts, something the grandfather had learned from his father long ago.

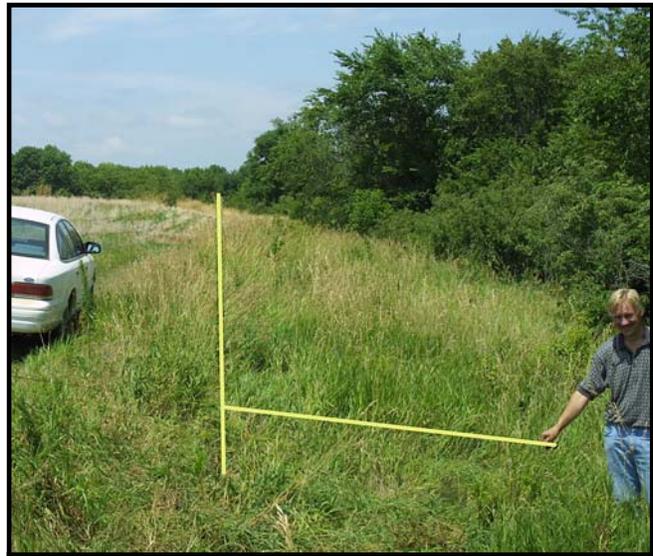
Photo 5 – Site of the overturn showing the location of the post and the downward ground slope of 8 degrees.

The ground was sloping (about 8 degrees) near the post, and the tractor was facing uphill. This may have contributed to the overturn and the rollbar failure. It took a few degrees less rotation and time for the tractor to reach the point of no return, leaving less time to react and stop the overturn. Secondly, the downhill behind the tractor allowed more rotation and momentum before the rollbar crashed into the ground, increasing the forces on the rollbar. After the incident, the post had loosened so that it could be removed by hand by those who arrived at the scene. The boy was dead at the scene when emergency crews arrived.

Recommendation 4: *The rear wheel of a tractor should not be used to pull posts from the ground.*

Discussion: Tractors have sufficient power and torque to cause an overturn under a variety of conditions. Many rear overturns occur when pulling heavy objects, where the chain is attached higher than the centerline of the rear axle, such as the three-point hitch upper linkage. When the rear wheel is attached to a strong deeply-embedded fence post, there is a great risk that the tractor will overturn, or that the chain will break. This method has been used, especially in the past, when three point hitches and front-end loaders were not common on tractors. In this case, the chain was attached to the back side of the wheel, and the tractor was driven forward to lift the post. A safer alternative

would be to attach the chain to the front side of the wheel, and back up. In that case, the torque from the wheel will push the front down rather than up. However, even this method is not recommended, as there are great risks for breaking equipment and causing injuries. Safer methods include using the three-point hitch, special jacks designed to pull fence posts, or a front end loader and large enough tractor for pulling posts from the ground.

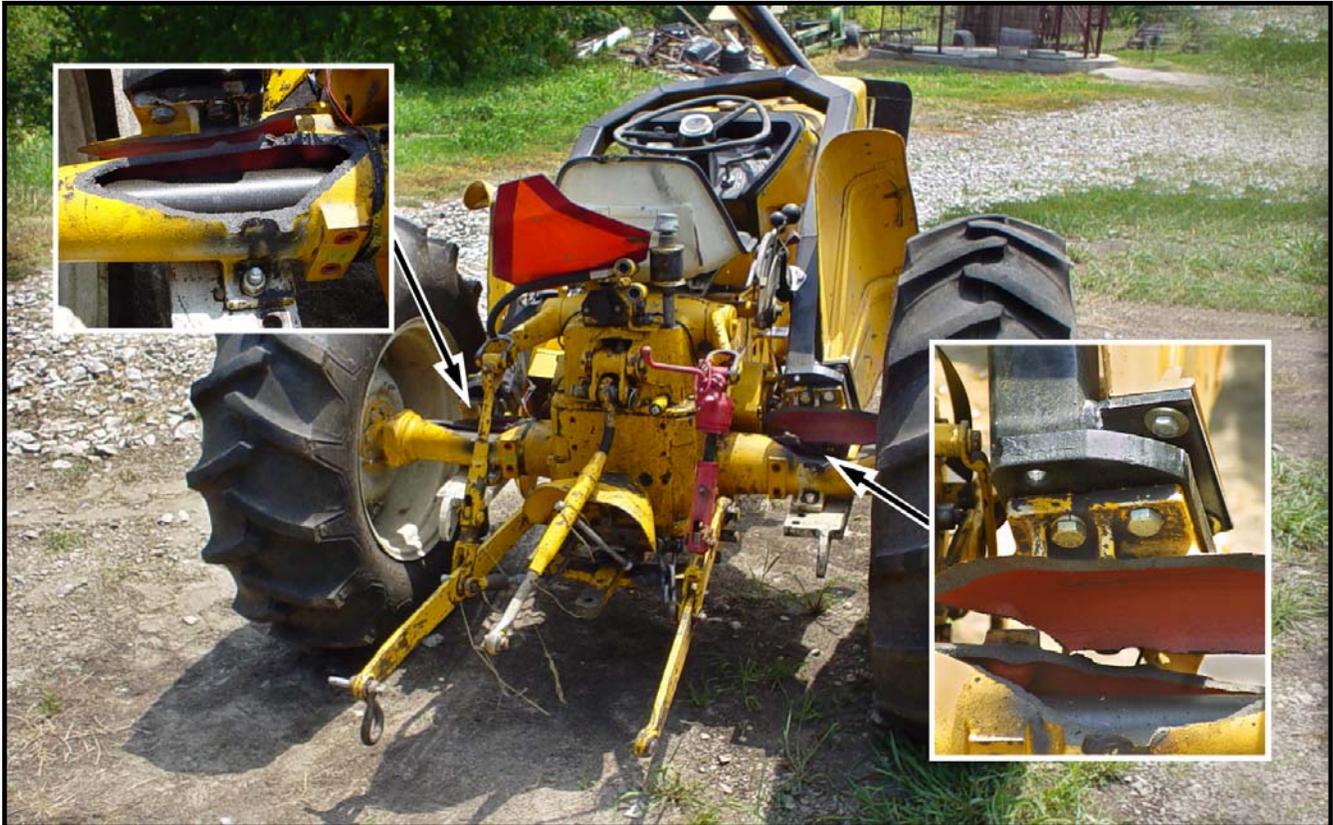
tractor forward, the post did not budge, but the tractor's front end immediately jumped upward. The grandfather yelled for him to push in the clutch pedal, but there was no time to react or stop the overturn. The front end continued to rise and the tractor rolled over backwards, slamming to the ground and instantly killing the boy. The rollbar collapsed and failed to provide protection. It did not bend or break, but the cast iron axle housings on both sides broke, leaving large pieces of the

Photo 6 – Rear view of tractor with inserted photo enlargement of left and right broken axle housings.

housing still bolted to the rollbar brackets. (see Photos 2, 3, 6).

By visual inspection, the 3/8 (9.5 mm) cast iron housing material did not have obvious pre-existing damage. The cast iron material appeared consistent in all areas on both sides where pieces were torn from the top of the housings.

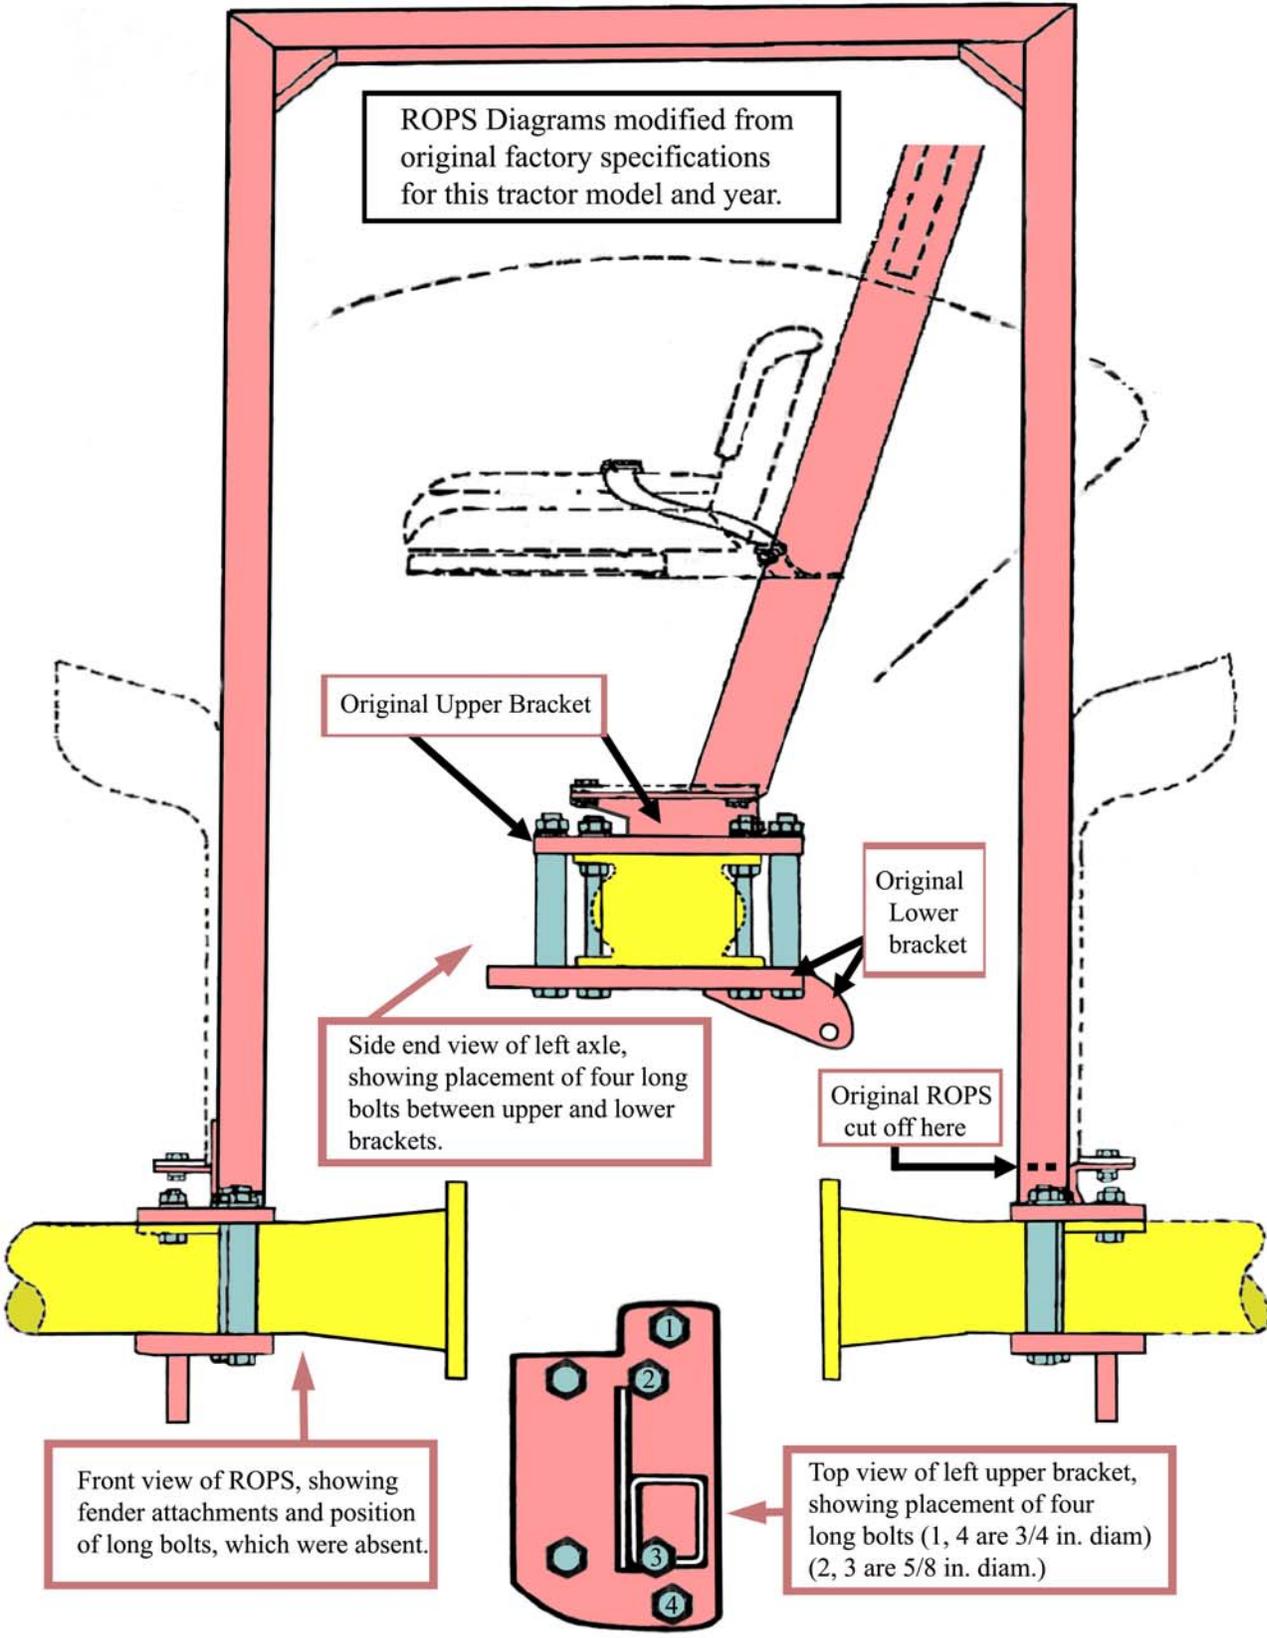
ROPS Diagrams modified from original factory specifications for this tractor model and year.

Both the top and bottom mounting brackets for the original ROPS were intact and in place (please see Diagram), however, the four 9-inch long (23 cm) bolts between the top and bottom brackets were missing. These bolts were an integral part of the ROPS design specifications and provided significant strength as they distributed mechanical stress to the entire axle housing in the event of an overturn. The bottom bracket was bolted only to the bottom mounting base of the axle, and the top bracket, with fender and new rollbar, was attached with short bolts to the top mounting base of the axle housing. The original bolt configuration is shown in the specification sheet (see Diagram).

Side end view of left axle, showing placement of four long bolts between upper and lower brackets.

Front view of ROPS, showing fender attachments and position of long bolts, which were absent.

Top view of left upper bracket, showing placement of four long bolts (1, 4 are 3/4 in. diam) (2, 3 are 5/8 in. diam.)

Recommendation 1: *Factory installed Roll-Over Protective Structures (ROPS) should not be removed from tractors.*

Discussion: About half of the 4.7 million tractors in the U.S. do not have ROPS³. Since 1985, manufacturers have provided ROPS on all new tractors sold in the US, and in some countries, ROPS have been required since 1960's. The tractor in this case originally had a factory installed ROPS. Some owners have removed ROPS to facilitate operation in low clearance buildings or orchards, or for other reasons. It is not known why the ROPS and mounting bolts had been removed from this tractor. Reportedly, the tractor was previously used by city employees and it had the 2-post factory-installed ROPS in place. It is likely that the original ROPS, if properly installed, would have provided protection in this case. Using an approved ROPS and seat belt provides a protective envelope around the operator, and in many cases, prevents the tractor from overturning completely.
