Case No: 00IA03101

Report Date: January 2001

SUBJECT: Worker Dies When Tower Crane and Water Tower Crash to the Ground

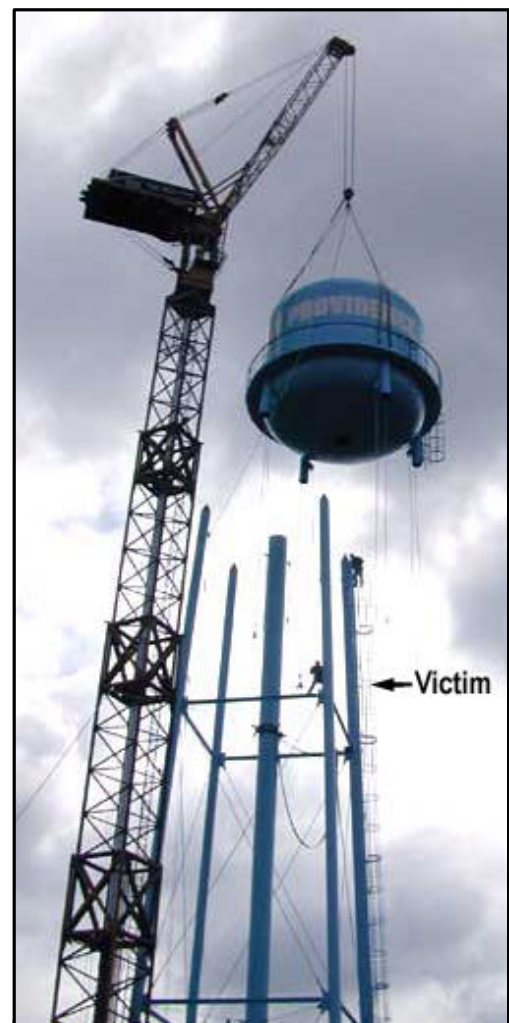
A 29-year-old worker for a water tank company was killed when the partially assembled water tower he was working on was struck by a falling portable tower crane. The man was part of a three-man crew that reconditions and relocates used water towers, this one intended for a small rural Iowa community. An independent crane company was hired to erect supports for the water tower and lift the tank into its final position. This company erected its portable tower crane adjacent to the new foundations for the water tower, as close as possible. (see Photo 1). After hoisting the tank and while swinging it into position, with just a few feet to go, the rear crane outrigger facing the water tower slipped between cribbing timbers and sank into the ground. The entire tower crane fell towards the water tower, smashing everything in its path. The victim was sitting on a horizontal strut of the water tower base (see Photo 1), approximately 80 feet in the air, preparing to adjust and tighten bracing rods once the tank was in position. Two other workers were injured, another member of the tank crew, who was positioned inside the ladder cage for the water tower, and the operator of the crane, who was sitting inside the control box of the crane 120 feet above the ground. Photo 1 was taken by a newspaper reporter a few minutes before the crane fell.

Photo 1 -- Picture of water tower taken a few minutes before the incident.

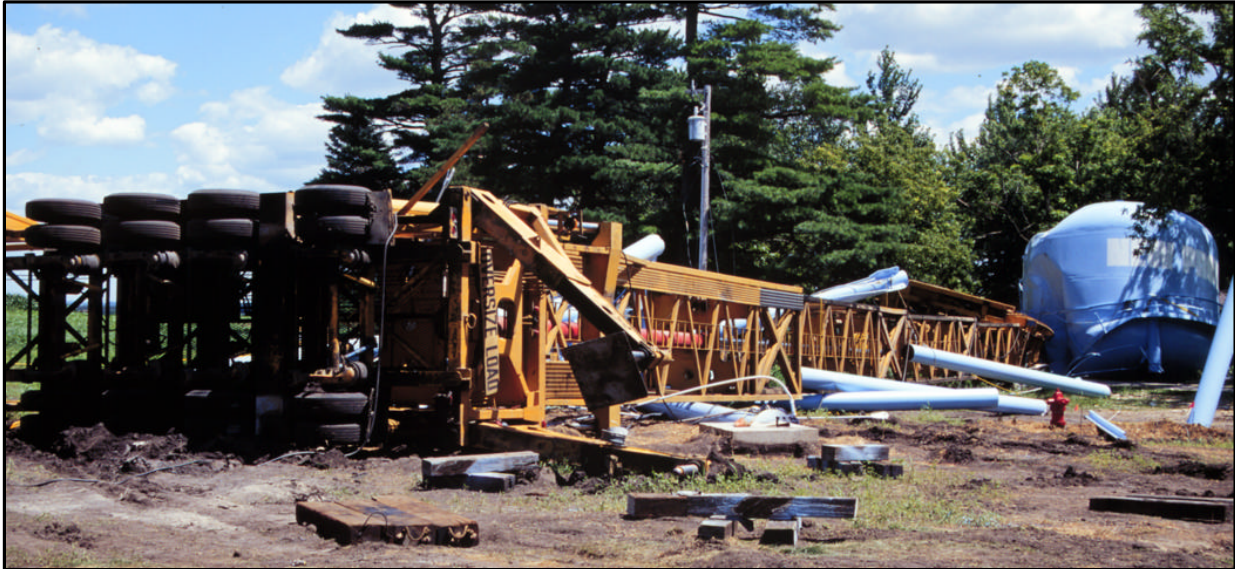
Photo 2 -- View of the crash scene taken during investigation -- photo shot from the rear of the crane trailer.

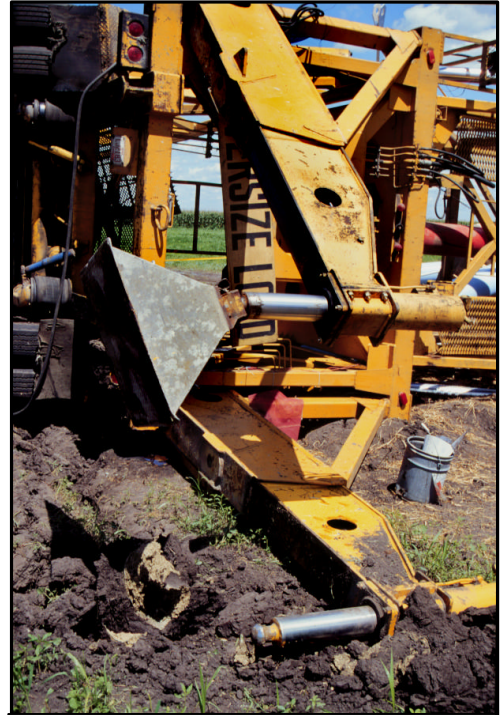
Photo 3 -- Close-up of rear outriggers.

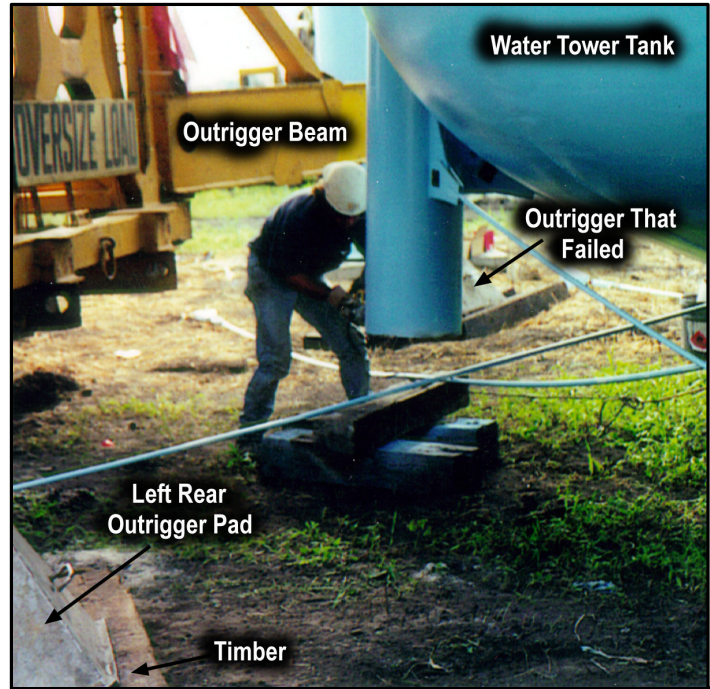
Shortly before the final lift, the water tank was raised a few feet off the ground to clean up the bottoms of the support legs (Photo 4). This photograph shows a glimpse of the outrigger and cribbing timbers that completely failed 20 minutes later. On a closer look at the photo (Photo 5), some details are noteworthy: (1) the ground is not level under the timbers, (2) the cribbing timber to the right has already begun to roll out from under the pad, and (3) there is a space between the right and middle timbers. The appearance of the timbers in this photo is consistent with the final position of them after the accident, as seen in Photo 6.

Photo 4 -- Tank worker preparing leg of the water tank.

Discussion: Evaluation of the incident circumstances indicates that the ground under the right rear outrigger had begun to fail early in the lift. As evidenced by Photo 4, the ground under the outrigger was already failing, yet the hoisted load was less than waist high above the ground. Had the ground condition under the outrigger been detected and correctly assessed at this point, there would have been time to lower the load and change the outrigger set up to one that was more stable. During the lift there were several workers on the ground, including the owner of the tank company and the foreman of the crane crew. Once the lift was begun, it lasted about 11 minutes, during which the ground under the outrigger continued to fail to the point that the lean of the crane caused it to become unstable and it fell over. It seems likely that the attention of ground observers would be focused on the lifted load and the workers on the water tower. However, as a crane lifts and then swings its load into position, the outrigger loading changes, increasing as the load is swung over them. To detect potentially unstable conditions, the entire crane setup should be observed during a lift.

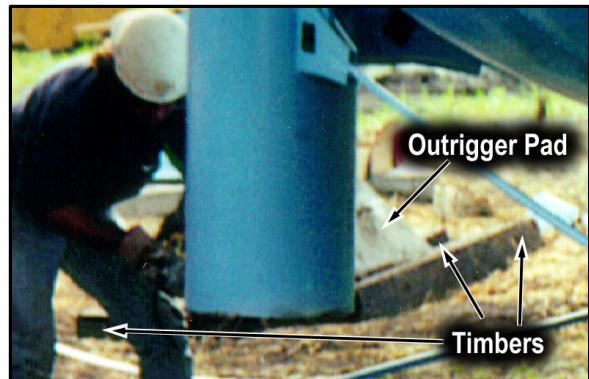
Photo 5 -- Close-up of timbers under the right outrigger that failed 20 minutes later.

Contributing to the occurrence of the incident was the manner in which the timbers were placed under the outriggers. As can be seen in Photos 4, 5, and 6, just prior to the incident, the cribbing timbers were rolling out from under the outrigger pads and spreading away from each other. Some crane companies we consulted always use plywood or steel plates under outrigger timbers to minimize shifting of the soil and/or cribbing rollout, even if they are setting up on highway concrete. In addition, some operators use long bolts through timbers to create a solid base, to prevent cribbing rollout (See Figure).

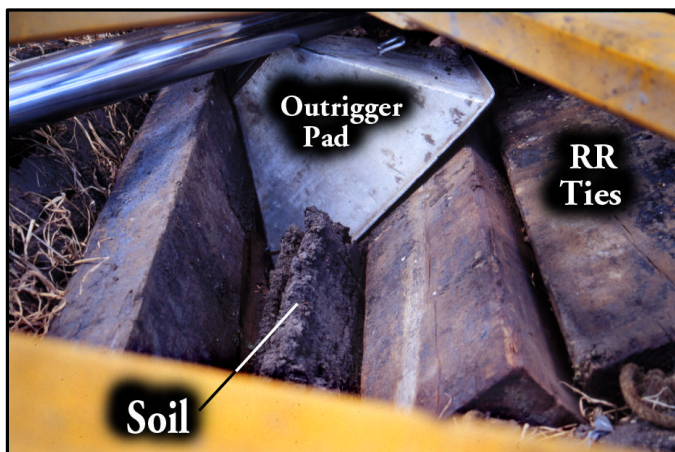
Photo 6 -- Failed outrigger pad and cribbing timbers.

vertically within 3 to 4 feet of the water tower legs when the right rear outrigger on the tower crane suddenly shifted and sank down between the timbers, causing the tower to fall towards the water tower structure (See Photo 6). The soft soil was pushed upwards, the stabilizer arm on the right outrigger snapped, and the outrigger arm swung to the rear of the trailer as the crane began falling. Witnesses report it took several seconds for the crane and tower to fall to the ground, taking nearby powerlines with it.

In this case, it is apparent that the rear outriggers were setup improperly. The ground was not leveled under the outrigger, and cribbing timbers were not placed close together, nor were other means taken to prevent cribbing rollout. It appears that much of the hoisted load was transferred to the middle timber, which was certainly not adequate to support the load. More significantly, adequate bearing area to reduce the outrigger loading below 2000 psf. may have prevented this incident.

Recommendation #1: *Crane owners and operators should ensure that cranes are properly set up with the outrigger pads supported by firm stable footing.*

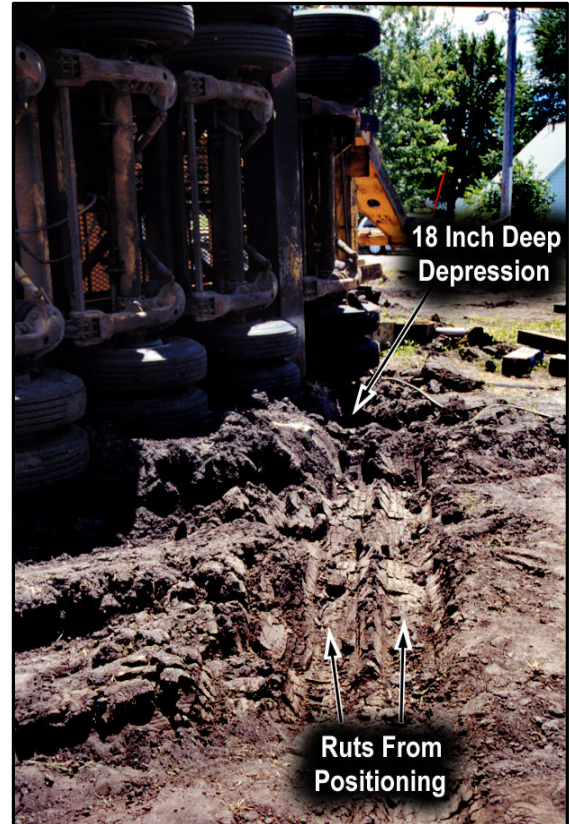
As mentioned, it was difficult for the semi-tractor to move the crane trailer into position because of the soft topsoil. Photographs show deep wheel tracks from the four sets of dual tires under the heavy trailer (See Photo 7). A local farmer with 30 years of farming experience described the soil as *"hard as pavement on top, yet pure gumbo underneath"*. He said the soil was very difficult to work; it drained poorly, and retained moisture more than other soils. This jobsite was flat; the ground surface was dry; the temperature was in the 90s, and there was essentially no wind that day.

Photo 7 -- Soft topsoil in construction area.
