**Case No. 2IA24**

**Report Date: 10/14/2002**

**SUBJECT: Tanker Truck Driver Killed by Unshielded PTO Shaft**

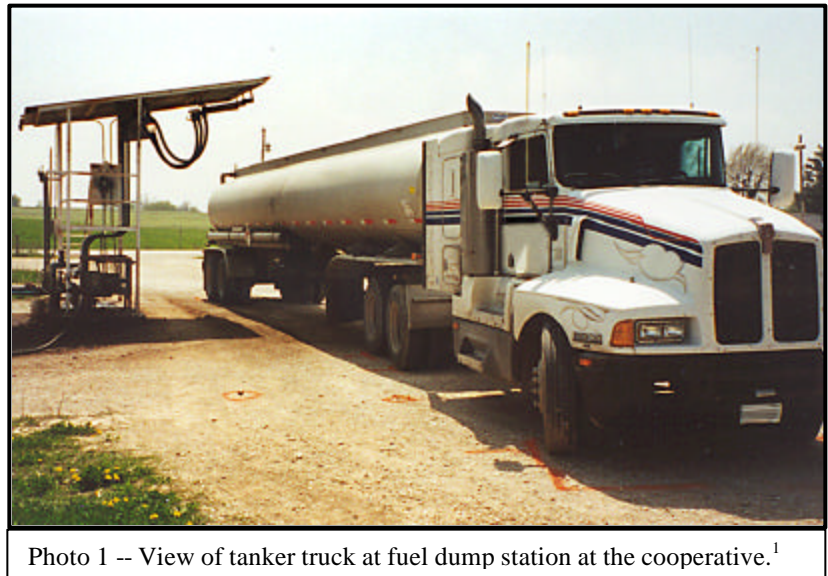
Photo 1 -- View of tanker truck at fuel dump station at the cooperative.<sup>1</sup>

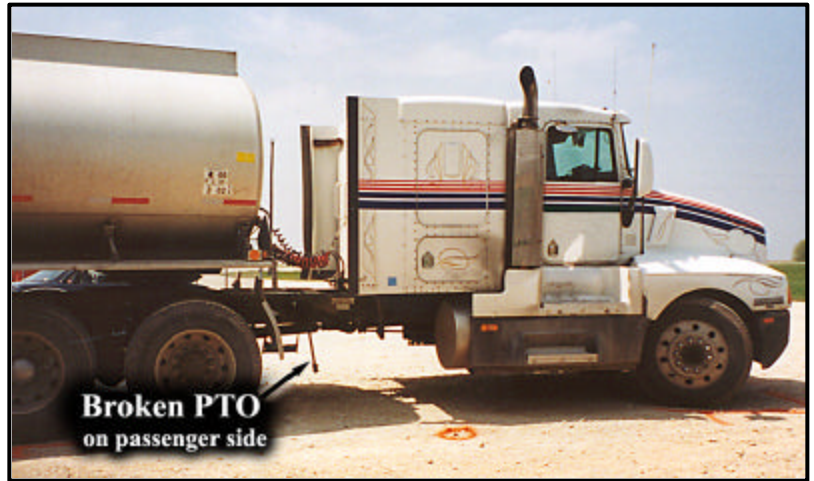
Photo 2 -- Passenger side of truck showing broken PTO shaft.<sup>1</sup>

The 1995 model truck tractor was one of two tractors used to pull tanker trailers, and the only truck that had PTO-operated fuel pumps. The other truck was equipped with hydraulic-driven pumps. The round, 1-inch (25 mm) diameter, PTO shaft was approximately 2½ ft. (75 cm) long, had universal joints at both ends, and was located on the passenger side of the cab, attached to the side of the frame. It was connected to fuel pumps mounted on the front of the trailer, and was actuated with hand controls and a foot clutch inside the cab area. The shield for the PTO was in place when it was last

**Recommendation #1:** *Employers and workers should ensure that PTO drivelines and other exposed drive-train components are shielded from contact with workers.*

**Discussion:** PTO drivelines are a well-known hazard. PTO's are commonly used in vehicles and machinery to transfer power from the engine to operating parts of the machine. In vehicles, the PTO drivelines to the wheels/axles/differentials are typically not shielded, but they are in locations where they aren't accessible during normal operation. All drivelines that are accessible must be shielded. The PTO shaft powering the fuel pumps in this truck tractor was located in a place where it was accessible in the space between the cab and the trailer. This type of driveline should be guarded. As reported by the company employees, it was guarded when the vehicle was last inspected, but at the time of the incident, the guard was missing. The employers should ensure that adequate vehicle maintenance programs exist and guards are kept in place. It appeared that the shield had been missing for some time. Workers should notify employers about missing shields and other safety hazards, and have them corrected without delay.

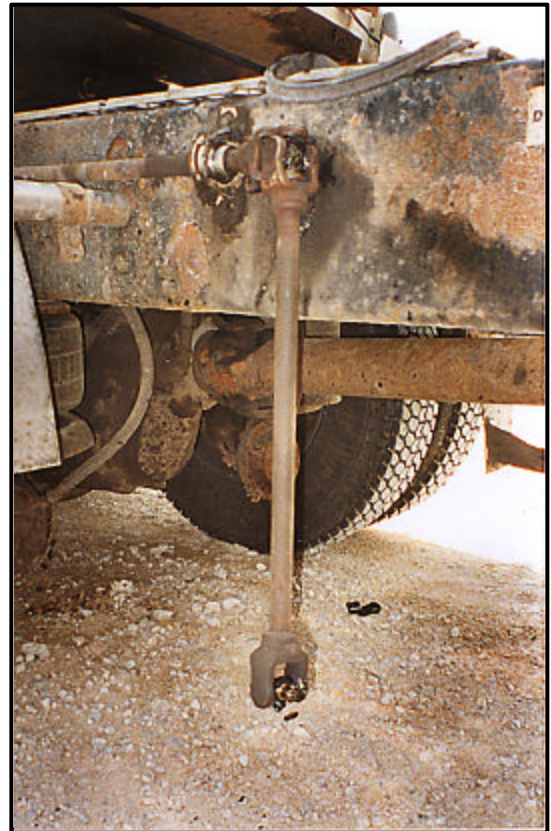
inspected, but had since been removed. At the time of the incident, the shaft was completely exposed. No employees or company supervisors could locate the missing shield, nor had information why, or when, it was removed. It is not evident (from Photo 3) how the shield was attached to the truck. The paint, wear, dirt, and grease marks on the frame indicate the shield may have been missing for some time.

Photo 3 -- Close-up of broken PTO shaft.<sup>1</sup>
