TO: Director, National Institute for Occupational Safety and Health

FROM: Iowa FACE Program

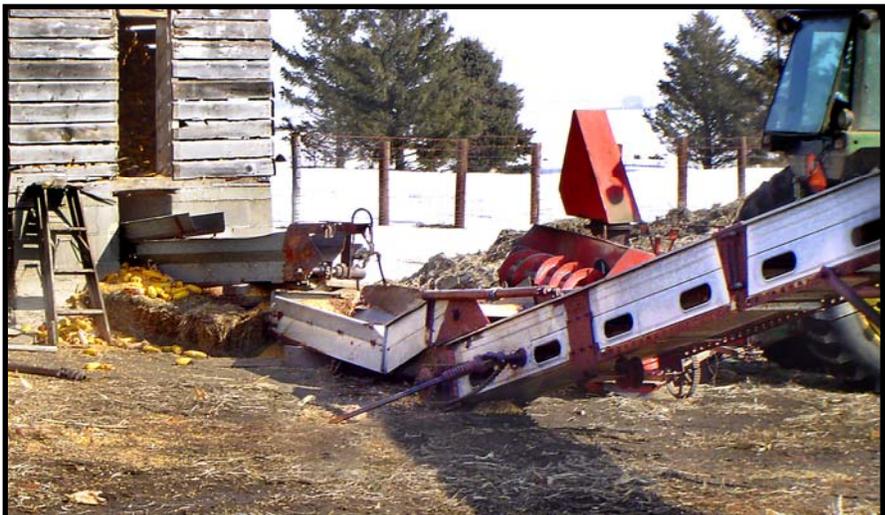
Photo 1 – Overview photograph of the area, showing the east end of the corn crib, the chain drag conveyor, and the flight elevator with half of the PTO driveshaft attached.

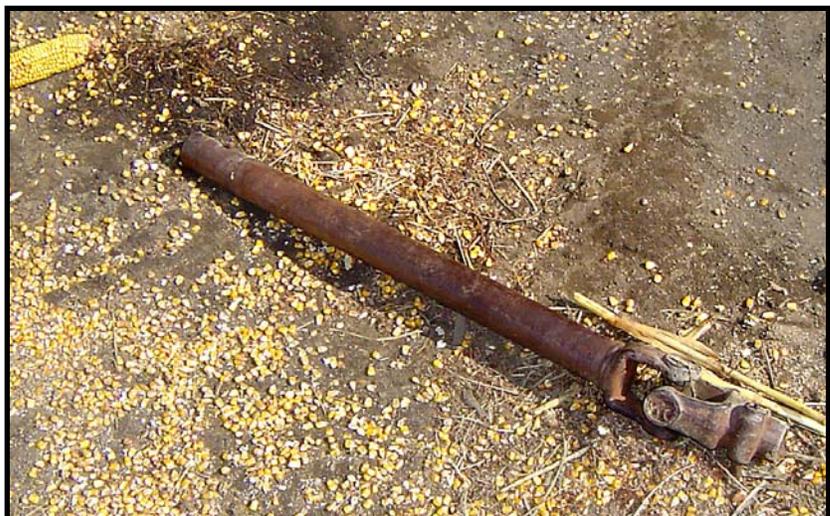
Photo 3 – Tractor end of PTO driveline, with no evidence of shielding.
