FROM: Iowa FACE

Case No. 2002IA030

SUBJECT: Front Hopper Gate Operator Run Over by Chip Spreader during Street Resurfacing

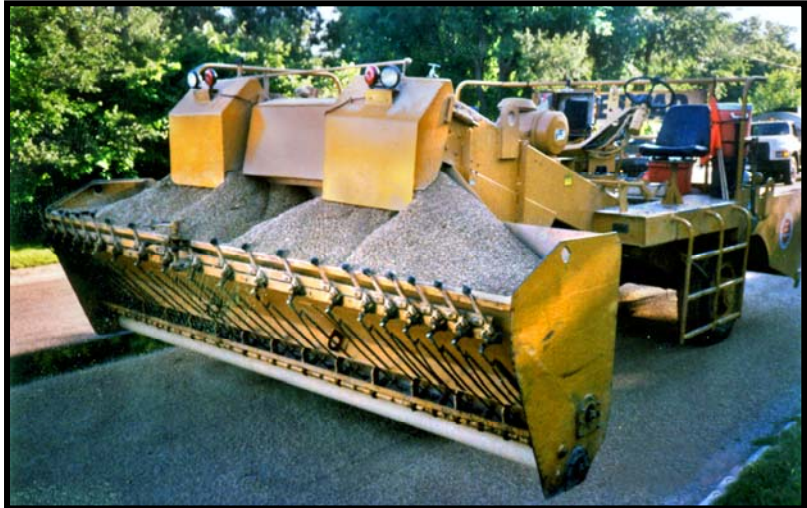
Photo 1 – Front view of the rock-chip spreading machine, showing the hoppers for the chips, the operator's seat position, and the inherent blind spot at the right front corner of the machine.

During normal operation the primary operator of the rock-chip spreading machine slowly drives forward on the roadway being resurfaced with a rear-facing dump truck in tow. The primary operator's station for this chip spreader is located at the left rear (Photo 1), resulting in a restricted view of the area to the right front of the machine. The dump truck driver remains in the truck's cab with the truck's

Recommendation #3 – *Manufacturers of chip spreaders should implement engineering controls to reduce excess noise and designs that do not require an operator other than the primary operator.*

Discussion: Engineering controls should be considered to reduce excessively loud noise from this equipment, which could result in improved communication. It is also possible that slip-resistant surfacing or additional safety railings at the side-gate operator's station on this chip spreader might have

prevented the victim from slipping and/or falling. However, designs that do not require an operator in this position should be the preferred means to prevent exposure.

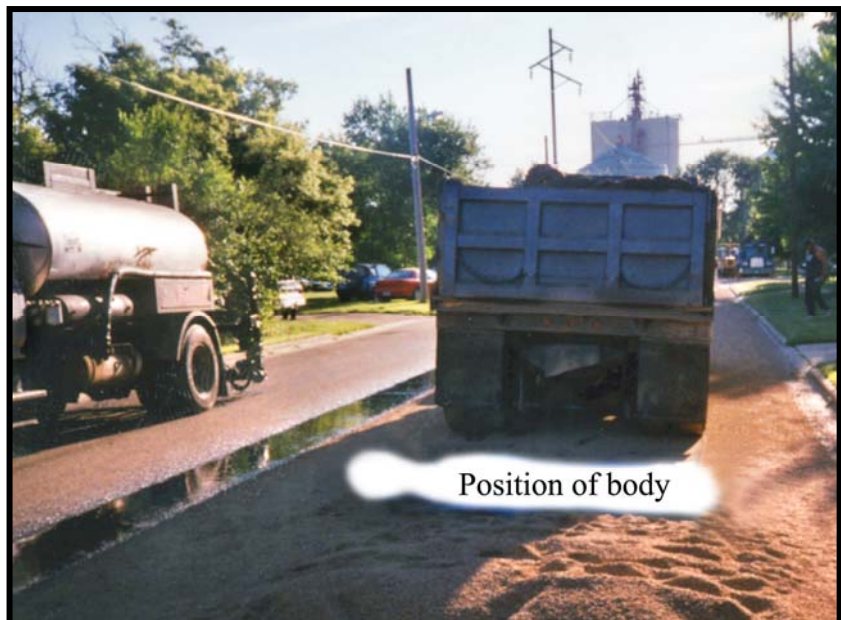
Photo 2 – Rear of the dump truck showing position of the victim's body.

Neither the primary operator nor the dump truck driver saw the victim fall. The victim was run over by the rock chip spreading machine and then by the duals of the rear axle of the dump truck trailing the chip spreader. The dump truck unhooked from the rock chip spreading machine and stopped moving as its rear dual wheels ran over the victim. The truck driver stopped his truck, got out of its cab, and immediately saw the victim between the first and second set of rear dual wheels on the driver's side of the truck.

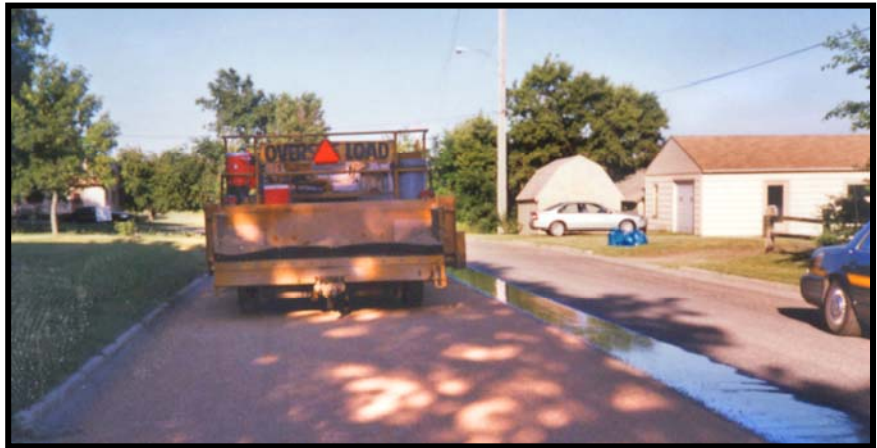
transmission in neutral and raises the truck's box to control the transfer of aggregate to conveyors in the rear hopper of the chip spreading machine (Photo 4). The side-gate operator for the chip spreader is responsible for controlling the uniform, final flow of rock-chips applied to the roadway. Given the high noise level of the machinery in operation, hand signals were the means of communication between the primary operator, the side-gate operator of the chip spreading machine, and the driver of the dump truck.

Photo 4 – Rear of the rock-chip spreading machine.
