FROM: Iowa FACE Case No. 2004IA021 Report Date: 22 June 2007

SUBJECT: Farmer Run Over by Tractor and Rotary Cutter

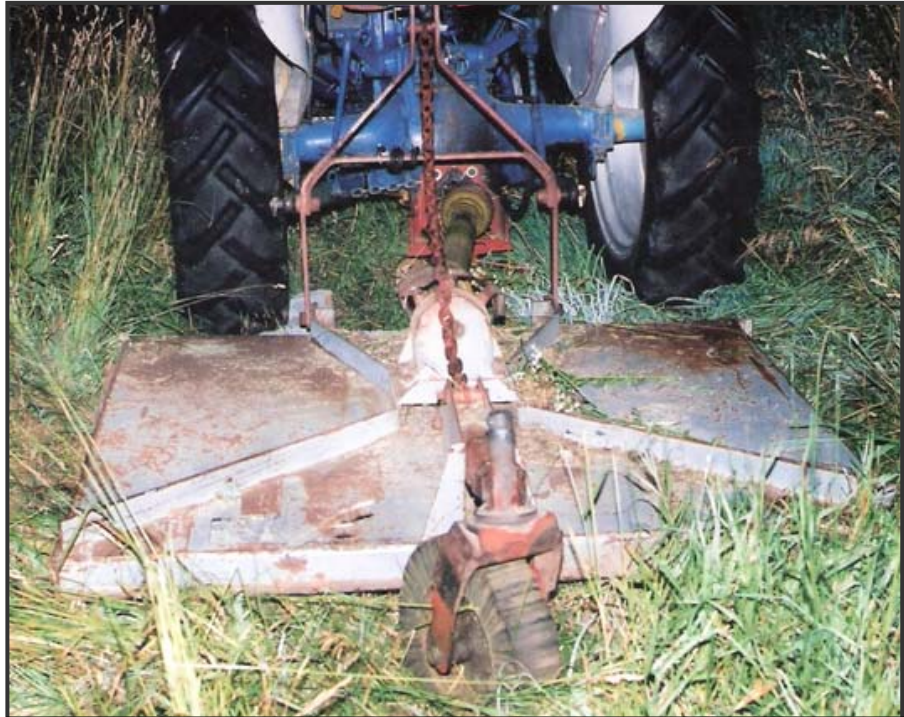
The victim was last seen alive by a neighbor around 7 PM the evening of the incident. He was mowing brush and grass with a tractor and the attached rotary cutter. The grass was 3 ft (1 m) tall. He was using a 5-ft (1.5 m) wide, power takeoff (PTO) powered rotary cutter mounted on the rear three-point hitch of a 27 PTO Hp (20 kW) tractor that was over 50 years old. The tractor had a wide front axle configuration. Its rear wheel track width fit the width of the rotary cutter's swath. The tractor did not have a cab, ROPS or seatbelt.

Officials estimated the farmer was still "brush hogging" with his tractor and rotary cutter combination about 10 PM when the wheels on the right side of the tractor drove up on a tree stump that was hidden in the tall grass. The farmer was pitched from his position on the tractor to the front left, ahead of the tractor's left rear drive wheel. The tractor continued forward. Its left rear wheel ran over the farmer's neck and chest and the PTO-powered rotary cutter followed as the farmer went under its deck (Photo 1). The tractor engine stalled and power to the rotary cutter stopped with the victim pinned between the left front quarter of rotary cutter and the ground.

Photo 1 – PTO-powered rotary cutter attached to the tractor's three-point hitch.

Discussion: The tractor in this incident had no ROPS or seatbelt available for it when it was manufactured in the early 1950's or before. While the primary purpose of ROPS and seatbelt is to protect the operator in the event of an overturn, the ROPS structure and seatbelt can also be important in preventing an operator from being thrown from the tractor. ROPS are commercially available, from either the original tractor manufacturer or from aftermarket sources, for tractors built since 1970 and for many makes and models built prior to that time. Rollover protection includes a seatbelt to keep the operator in a protected zone and restrains them from being thrown from the tractor. A seatbelt should not be installed or used on a tractor that does not have rollover protection. A ROPS with seatbelt installed on the tractor in this incident of sudden, rough, and unexpected movement without the tractor actually overturning could have prevented the operator from being pitched off and subsequently runover. Equipment dealers, Cooperative Extension, and the internet can provide information on sources of ROPS.
