Case No. 31A56

Report Date: Aug. 30, 2004

SUBJECT: Farmer Killed in Tractor Rollover While Setting a Fence Post

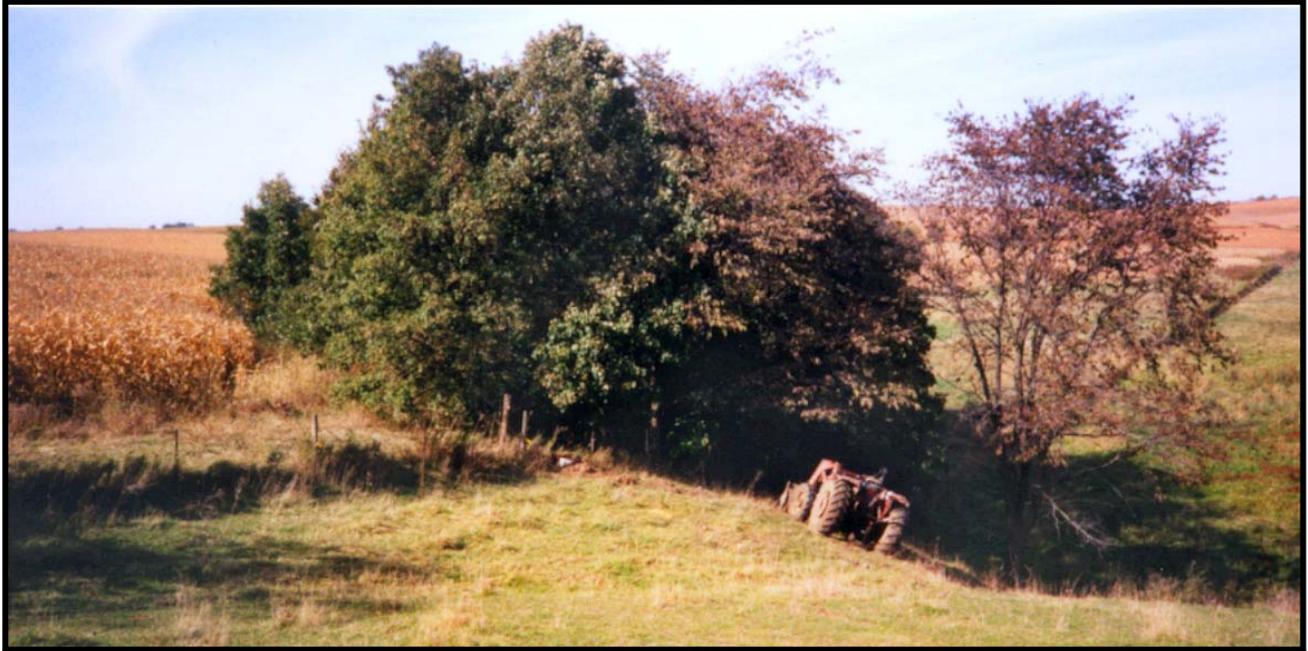
Photo 2 – Long shot of the entire scene, showing the slope of the pasture and the up-righted tractor.

The farmer partially filled the front bucket with dirt, then, positioned the tractor to put in the fence post, working in a pasture area, which sloped slightly to the right (see Photos 1, 2). As usual, the farmer was operating the tractor, while his son assisted by positioning the fence post. The middle of the front bucket was placed on top of the post, then, the post was pushed or rammed into the ground. But the soil in the area was rather dry that day, and the post could penetrate no more than six inches.

Recommendation #1: *All tractors should be equipped with Roll Over Protective Structures.*

Recommendation #2: *Factory installed Roll-Over Protective Structures (ROPS) should not be removed from tractors.*

Recommendation #3: *Alternate methods of installing fence posts should be considered.*
