FROM: Iowa FACE Program

Case No. 3IA45

SUBJECT: Auto Mechanic Dies from Explosion While Welding a Barrel in His Shop

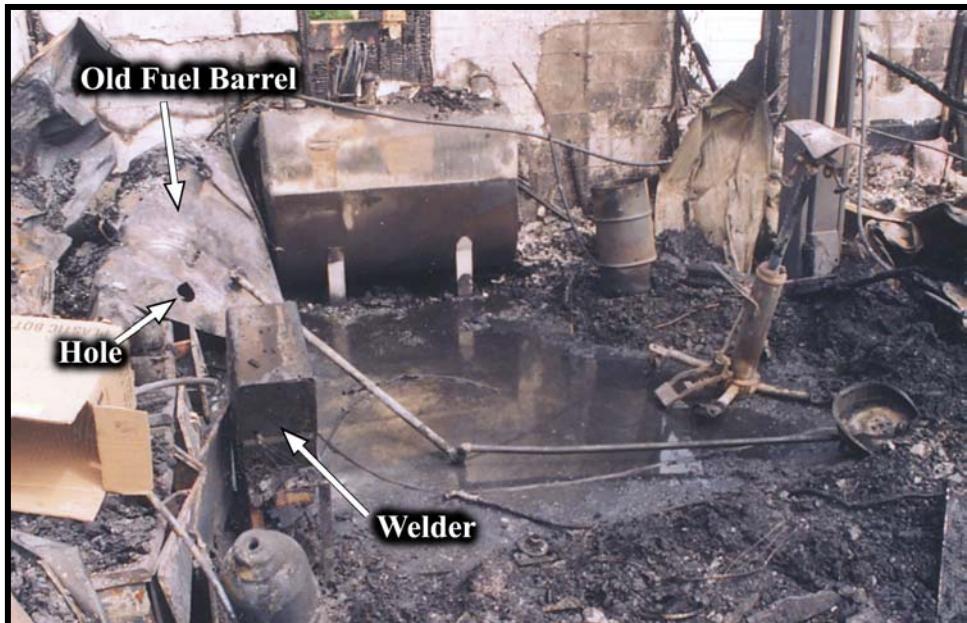
Photo 1 – View of the burned out shop area, showing the old fuel barrel and welder.

This auto repair shop had built a system for collecting used engine oil from vehicles. The oil was stored in an old 250 gallon fuel barrel, as seen in Photograph 1. This barrel had a bung hole on the top side and a welded pipe fitting connected to an articulated arm made of one-inch steel pipe. The other end of the pipe had a welded oil pan for collecting used oil (see Photo 2). When a vehicle needed its oil changed, it was raised off the ground with a hydraulic lift, and the oil pan was positioned under the engine oil drain plug. The oil pan and articulated arm were held in place under the vehicle with a simple bungee cord.

Recommendation #1 *Special procedures must be followed when welding containers.*

Discussion: 29CFR1910.252 describes specific safety procedures for welding. These procedures include removing and taking all movable fire hazards in the vicinity to a safe place, protecting all combustible materials from sparks, having fire extinguishers readily available, using fire watchers if there are combustible materials close to the point of operation, and inspecting the area and authorizing the work before welding. Welding is prohibited in the presence of explosive atmospheres (mixtures of flammable gases, vapors, liquids, or dusts with air) or atmospheres that may develop inside un-cleaned or improperly prepared tanks, which have previously contained such materials. Specific regulations for welding or cutting containers state that no welding or cutting or other hot work shall be performed on used drums, barrels, tanks, or other containers until they have been cleaned so thoroughly as to make absolutely certain that there are no flammable materials present. The containers must be vented, and purging with inert gas is recommended.

There have been many similar reports of explosions from welding on used oil drums, fuel tanks, gas barrels, etc. Even when empty, these containers may retain an explosive mixture, which can explode from welding sparks. Any containers must be thoroughly drained, cleaned, and vented (and preferably purged with inert gas) before welding or cutting.

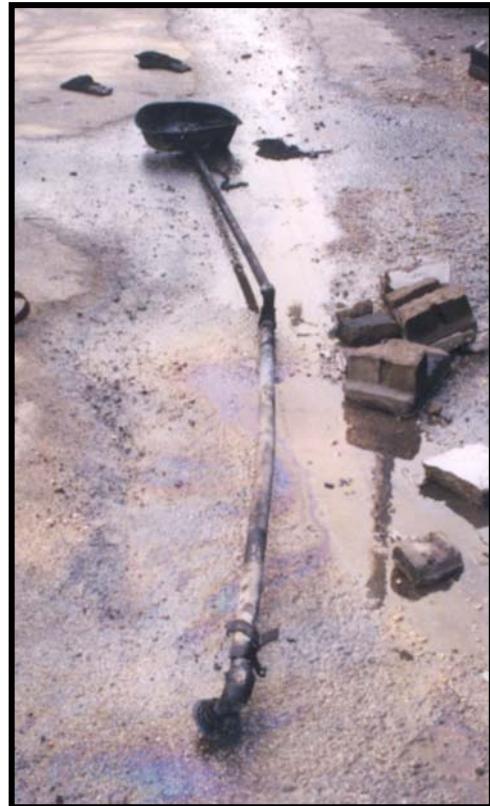
Recently, one employee did not use the bungee cord, and the weight of the articulated arm cracked the weld around the hole on the oil tank. The employee was told to repair the tank, and his plan was to drain the barrel of oil and fill it with water before he began welding. Apparently, at this time the employee had a vacation already scheduled, and he didn't have time to repair the barrel before he left, but was planning to do so when he returned to work. The victim, however, was unwilling to wait until that time, and being the owner of the shop, chose to repair the used oil barrel himself. The barrel had broken once before in the same location, and the victim had successfully repaired it at that time without any problems.

Photo 2 – Articulated pipe with oil pan on one end, and broken fitting for the oil barrel on the other.

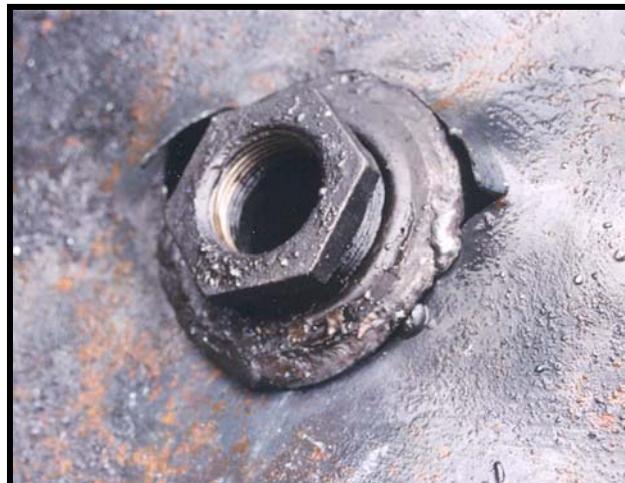
The victim was working alone, using a wire-feed welder. He had made one tack point on the barrel. When he began welding on the cracked area, the barrel exploded. The end of the barrel blew out, and the victim and his shop were instantly engulfed in burning waste oil. Neighbors heard the large explosion and rushed to help. The victim was seen running out of the shop, completely covered with burning oil, and a neighbor threw a blanket around him. The victim was conscious and talking, and was quickly transported to a local hospital and flown to a regional medical center's burn unit. His burn injuries were severe, with 3rd degree burns on 90% of his body, including inhalation damage. He died a few hours later. The auto repair business was completely destroyed in the ensuing fire.

Fire investigators learned that the man had changed oil on a vehicle that morning, and that the barrel contained fresh used oil, which usually contains dissolved volatile components. It is assumed that fresh gasoline vapors in the oil tank ignited, causing the explosion. Over time, these vapors will dissipate if the container has access to open air. This may explain why the victim was able to weld the barrel at one point previously without incident.

Photo 3 – Close-up of bung hole showing broken welds that were being repaired.
