**Iowa FACE Report:**     **A 17-year-old (minor) farm worker was caught between the raised bucket of a wheel loader and the door header of a cattle shed**

**Case ID:**                 **2011 IA 039**

**Report date:**          **10 December 2013**

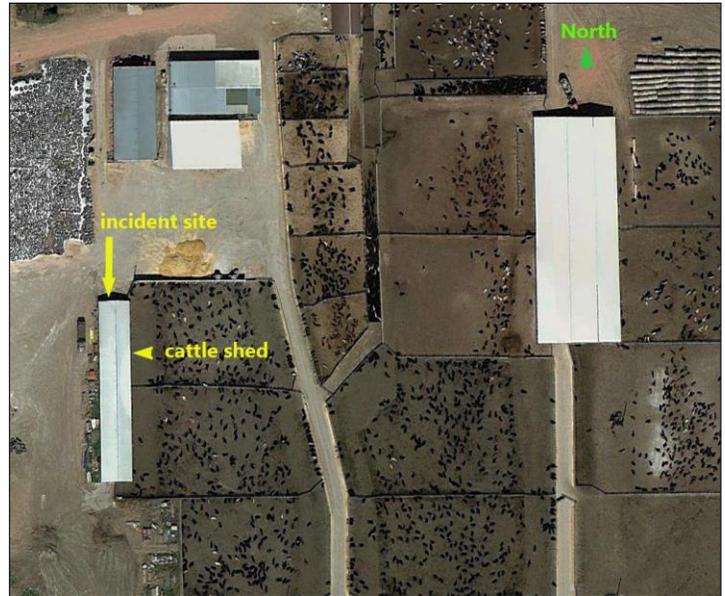
1. Aerial view of facility (Google Earth 2012 image)

The incident occurred at the north end of a 36-foot-wide by 200-foot-long cattle shed built in 2002 (Exhibits 1 & 2). The shed was oriented north/south and was open to a feedlot on the east side. The shed was wood-framed with a steel roof, steel cladding, and a concrete floor and alleyway. The alley ran through the west half of the shed and provided access for a tractor or loader to fill the 200-foot-long concrete feed bunk running the length of the shed (Exhibit 2).

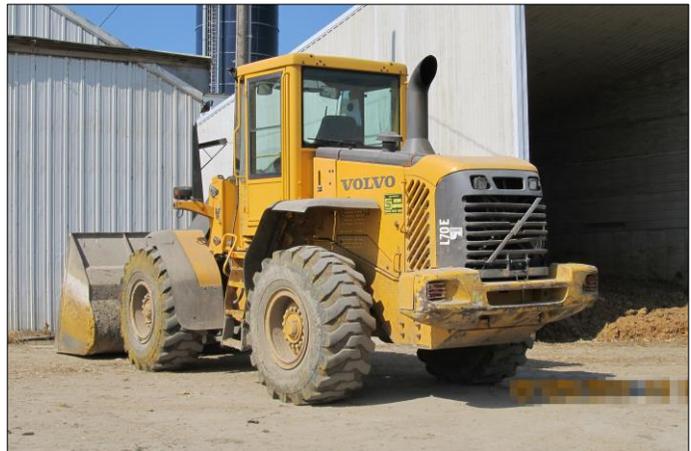
**4. View of wheel loader from rear**

The wheel loader involved in the incident was manufactured in 2003 or 2004 and purchased by the employer in used condition two and one half years before the incident. It was equipped with original equipment, including the large light material bucket attached on the front end (Exhibits 3 & 4). This wheel loader had a scale in the cab and was used mainly to weigh and move feed. The other wheel loader on site was used to transport other materials.
