Case No: 00IA03101

Report Date: January 2001

SUBJECT: Worker Dies When Tower Crane and Water Tower Crash to the Ground

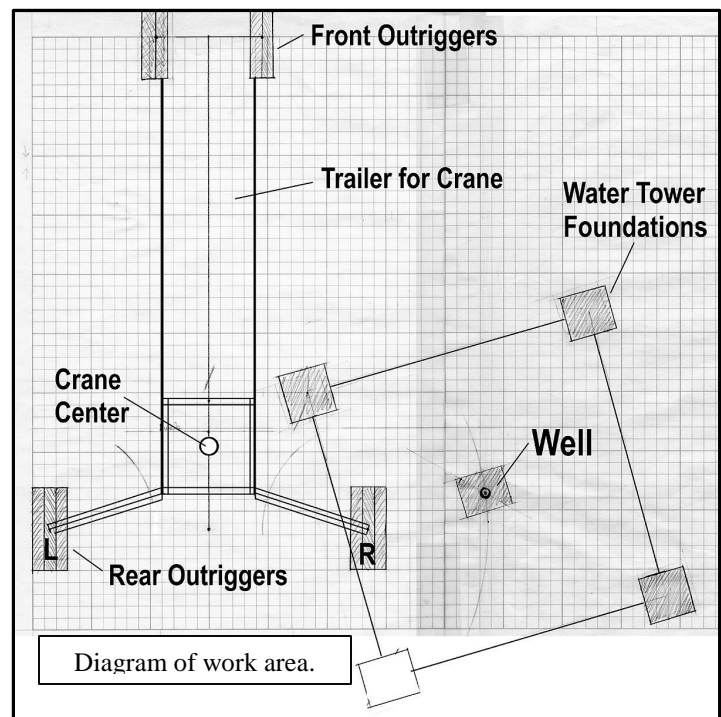
The investigation concluded that the tower crane fell directly in line with, and on top of, the right rear outrigger, complete failure of the ground under the right rear outrigger occurring soon after the full load was upon it. Although the top of the ground in the area was dry, deeper soil under the three timbers was wet and soft. The weight of the load squeezed this soil upward between the timbers (See Photo 6). There was a depression approximately 18 inches deep in the ground made from the right rear dual tires of the trailer (See Photo 7). This depression was evidently made when the outrigger failed and the complete weight of the hoisted load and the crane was momentarily transferred to the trailer before the tower fell flat to the ground.

Recommendation #1: *Crane owners and operators should ensure that cranes are properly set up with the outrigger pads supported by firm stable footing.*

Discussion: Construction projects frequently require the use of a mobile crane, which must be set up on soil that has recently been worked or backfilled for foundations, grading, etc. In addition, it is not unusual for crane operators to encounter frozen / partially frozen soil, wet soil, layered soil, changing weather conditions, etc. Because a crane's lifting capacity increases as the swing radius (distance from center of crane to lifted load) decreases, crane operators desire to set up as close to the worksite as possible. However, soil is frequently unstable in these locations and extra precautions are necessary to provide firm stable footing.

An evaluation of the outrigger loading based on information obtained from the crane manufacturer's operating manual indicated that the ground under the rear outriggers was subjected to a pressure of about 3600 psf., which is 1600 psf. greater than the soil's certified 2000 psf. capacity. See appendix for a more detailed description of the evaluation. Evidence at the incident site noted in Photos 4, 5, and 6, confirms that the ground was failing under the outriggers just prior to the incident. When the crane had been set up adjacent to the water tower, the rear outriggers had been set on three; 12-inch by 7-inch by 85-inch cribbing timbers, providing a bearing area of just over 21 square feet. To reduce the loading to a level of 2000 psf., it would have been necessary to increase the bearing area to about 39 square feet. This could have been accomplished by using appropriately sized steel or timber mats under the outrigger pads. In either case, the services of a certified professional engineer should be consulted to assure that the mats are of sufficient size and strength to support the crane and its load.

In this case, it is apparent that the rear outriggers were setup improperly. The ground was not leveled under the outrigger, and cribbing timbers were not placed close together, nor were other means taken to prevent cribbing rollout. It appears that much of the hoisted load was transferred to the middle timber, which was certainly not adequate to support the load. More significantly, adequate bearing area to reduce the outrigger loading below 2000 psf. may have prevented this incident.
